INSPECTION REPORT

For the Property at:
MEMORY LANE
HARVEST, AL 35749

Prepared for: HOME BUYER
Inspection Date: Monday, June 12, 2023
Prepared by: Steve Wehrman, AL-4164

RE: Report No. 2352, v.2
Memory Lane
Harvest, AL
35749

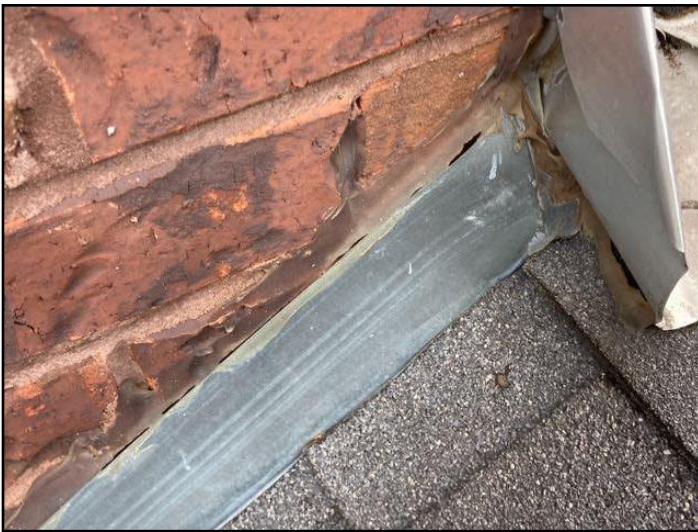
There are some caulking gaps at the front sidewall flashing (above the porch). Touch-up or re-caulk where needed.

1. Caulking gaps at front sidewall flashing

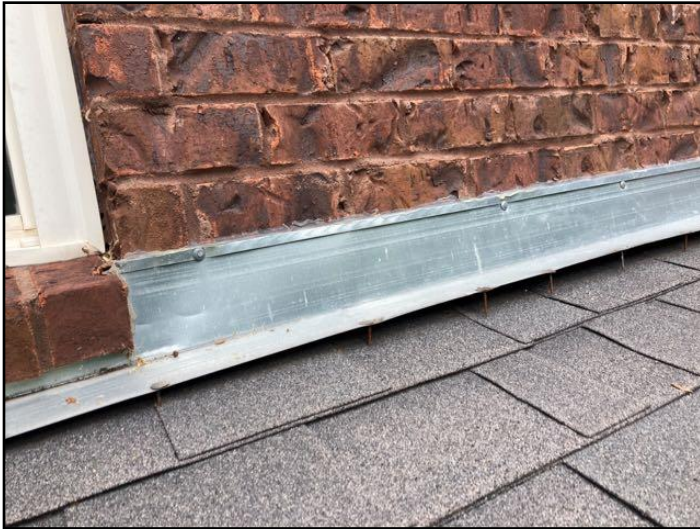
The sidewall roof flashing above the front porch has a loose or uplifted area. There is also an uplifted shingle or flashing area in front of the left side dormer. Secure the flashing where needed.

7. Flashing uplift

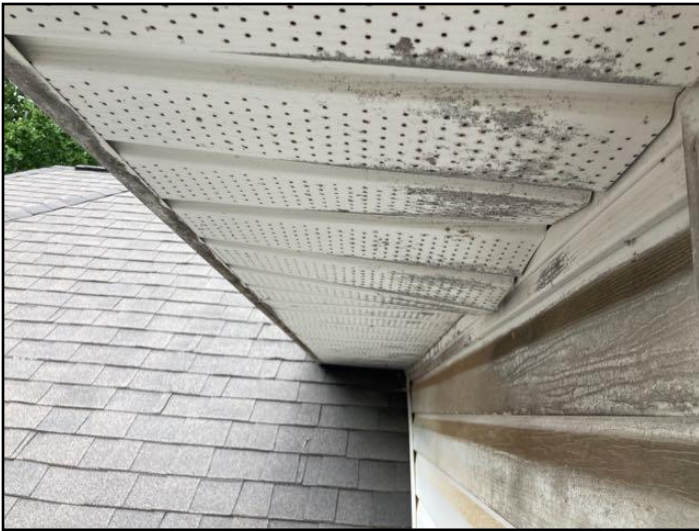
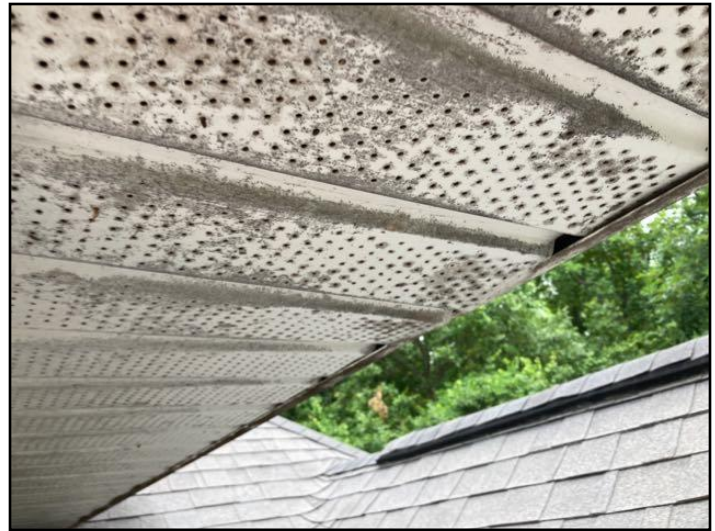
There is a hole in the right side soffit (likely caused by a squirrel). The hole can allow squirrels & other pests access into the attic. Seal/repair any holes in the soffits. Some of the vinyl soffit coverings have popped out of place. Secure where needed.

16. Soffit popped out of place

17. Soffit popped out of place

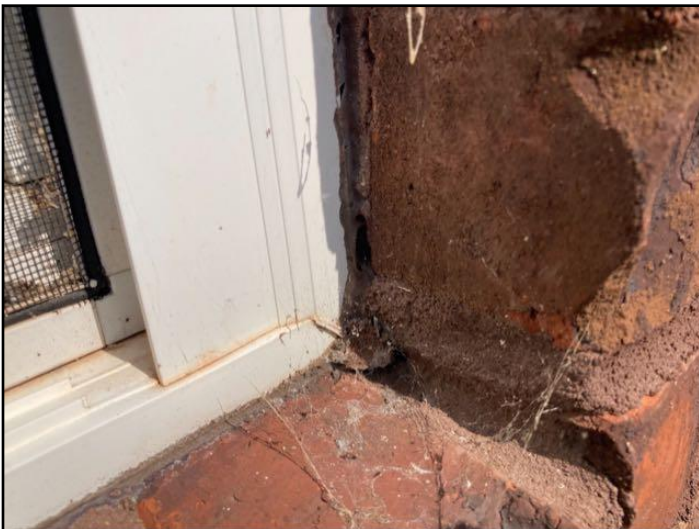
There are some minor gaps in the exterior brick mortar/caulk at the exterior windows & wall penetrations. Caulk/seal any noticeable gaps at the brick veneer. One small loose brick was noted above a rear foundation vent. Secure/repair the loose brick.

19. Caulking/mortar gap

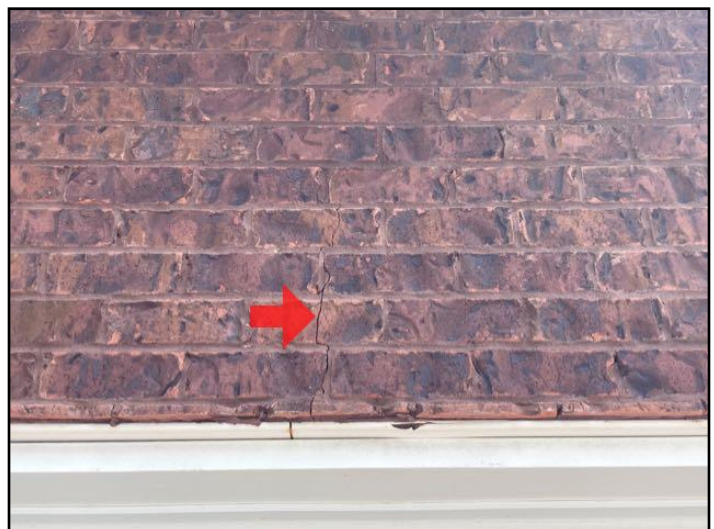
There is some hairline mortar cracking in the brick veneer above the garage vehicle door. Cracks in brick above wide garage doors are a common issue. The steel lintel (the thin metal that supports the brick above doors & windows) can sag or rust over time. The movement of the steel can result in brick veneer cracks. If the cracks and lintel sag increase--then repairs will be needed. The cracks can be monitored for movement--or the lintel can be evaluated by a structural engineer to determine if the lintel sag is above the allowable steel deflection rate. Discuss the issue with a brick mason or structural engineer if you require more in-depth information.

22. Brick veneer crack above garage door

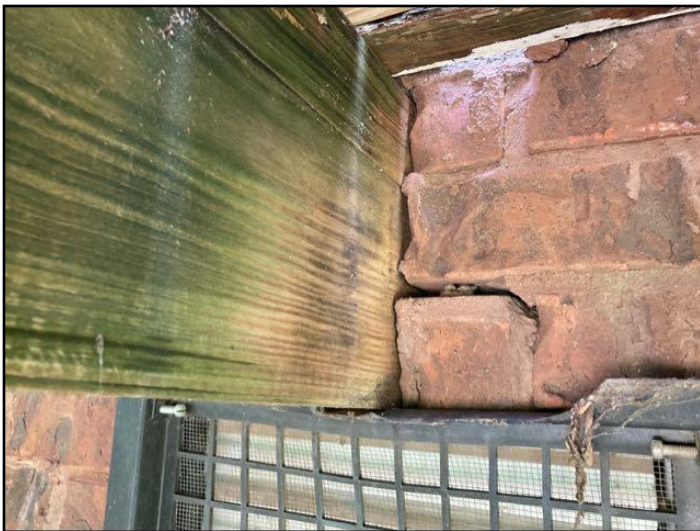
23. Loose brick at rear

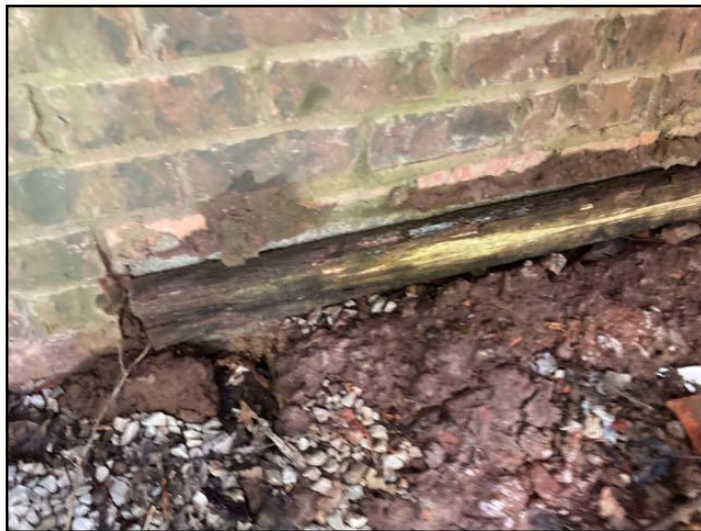
There is a 2x4 or similar lumber under the brick at the rear of the home. The wood was likely installed during the installation of the brick and should not be necessary for long-term brick support. The wood is deteriorating/rotting andfd may attract termites. Remove the wood.

24. Wood ledge at rear

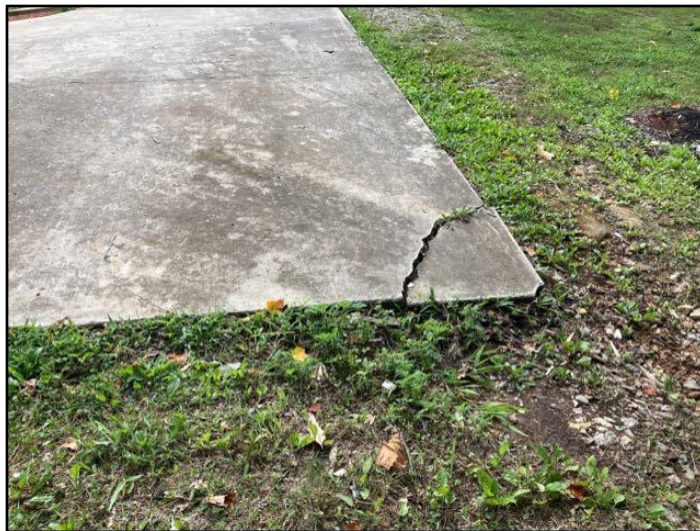
One of the driveway corners is broken/detached. Repair if desired.

27. Broken corner

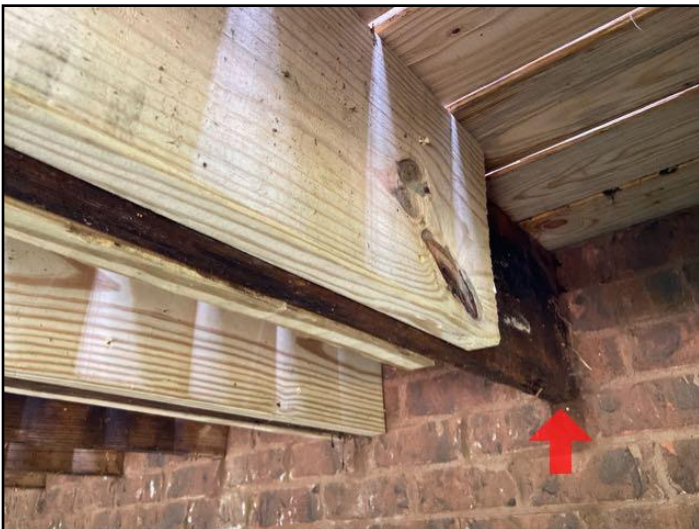
28. Sandwich repair not possible at bearing point

The deck should be evaluated by a reputable contractor and repaired & improved where needed. Any future deck improvements should follow The American Wood Council's prescriptive deck guide (free downloadable pdf guide that details how to build a safe deck to current standards). Ensure the deck is maintained regularly and repaired or improved in a timely manner.

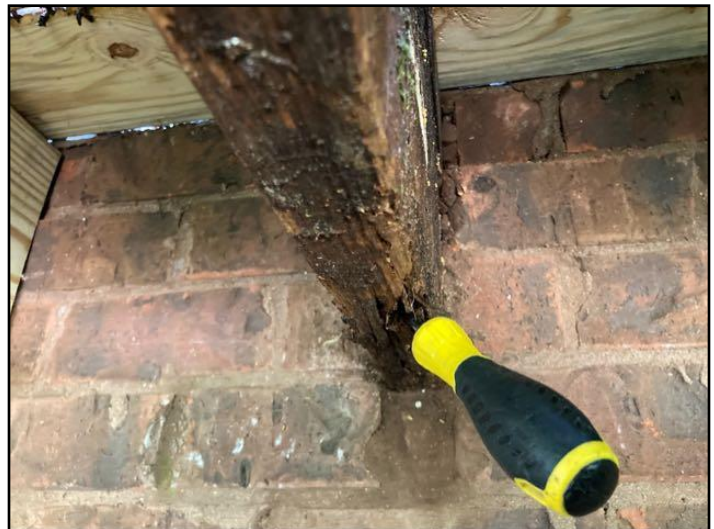
29. Soft wood

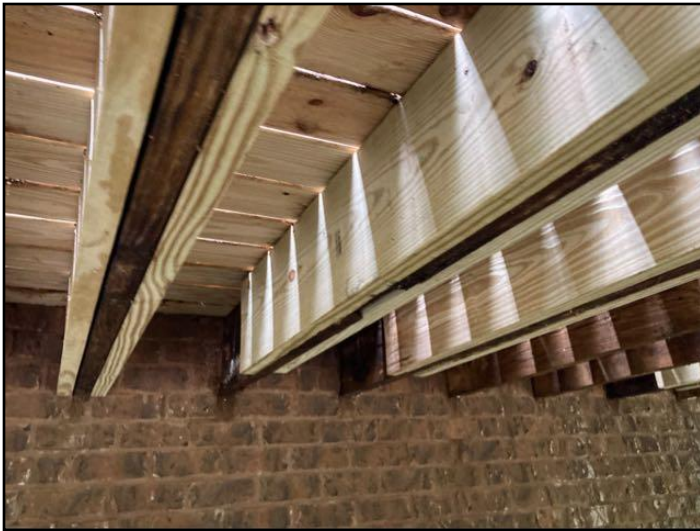
32. Deck repair

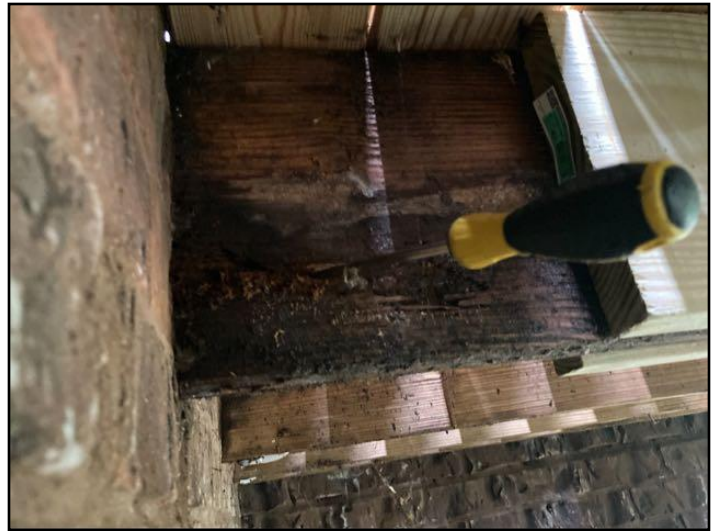
33. Soft wood

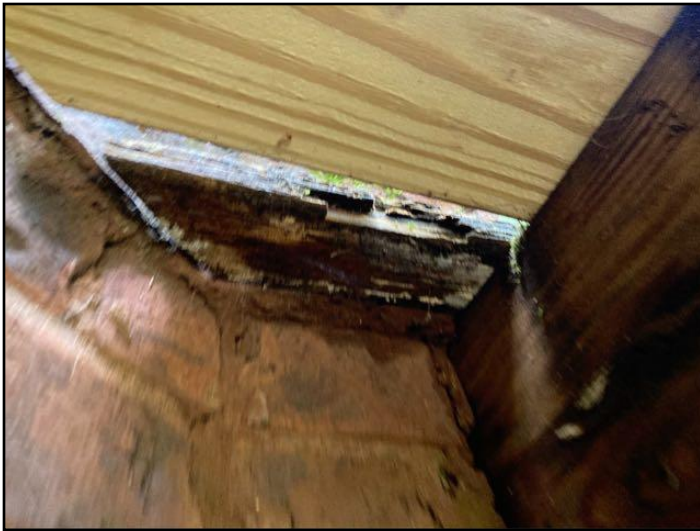
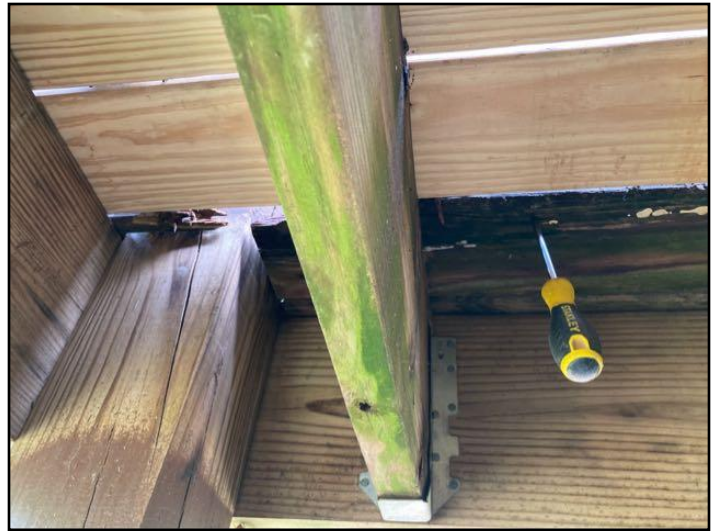
36. Rot/damage at deck edges

37. Rot/damage at deck edges

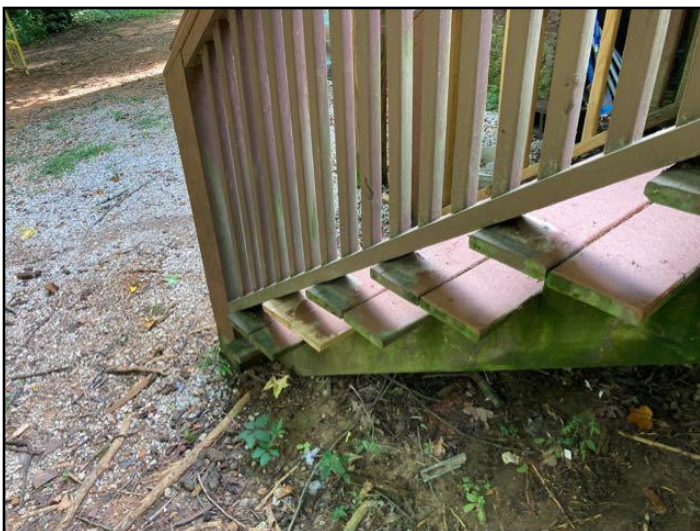
The deck stain is uneven or incomplete in several areas. Additionally, some areas have a thicker deck stain product than other areas. Improvement is recommended.

38. Uneven paint

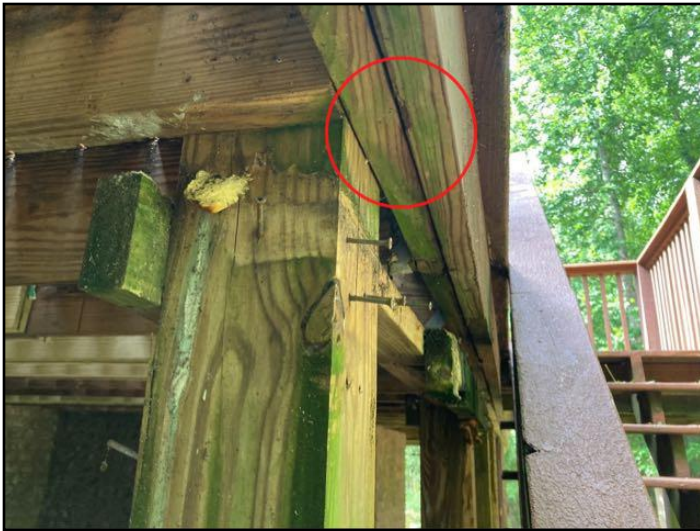
The outer deck beam girder has an improper connection detail. The beam is nailed or screwed to the faces of the columns. This puts all of the load/weight on the screws or nails used instead of on the actual beam and columns. Typically, the columns are notched for beam bearing--providing stronger support.

40. Improper beam connection detail

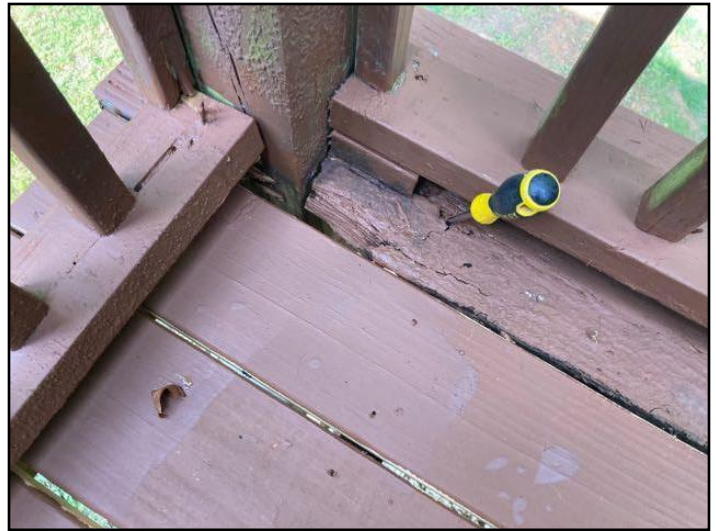
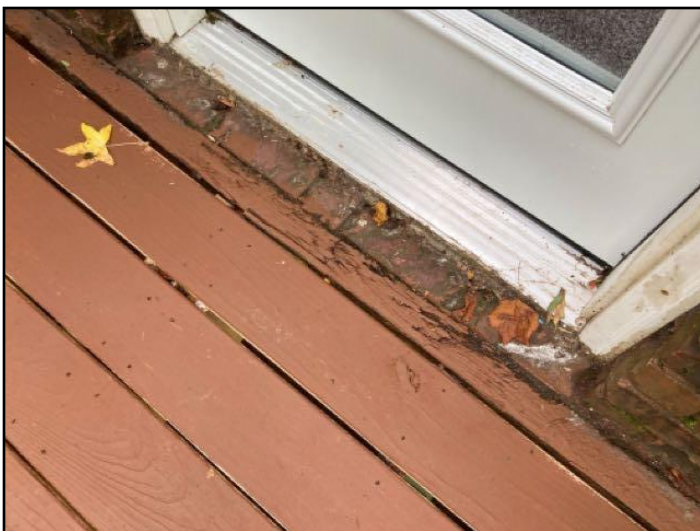
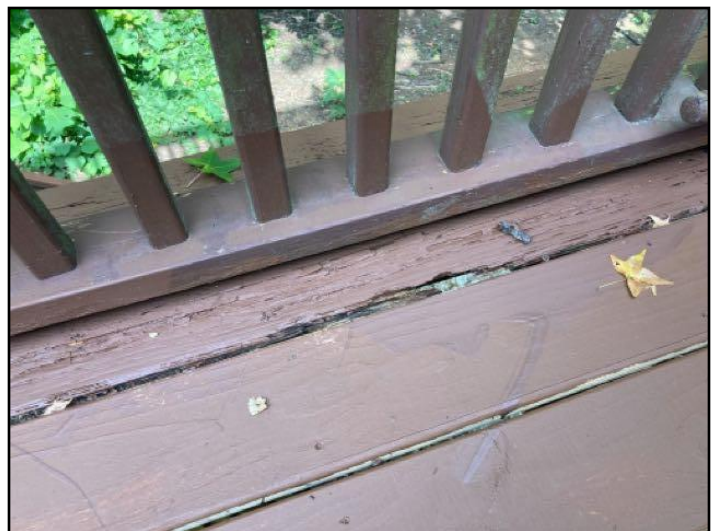
41. Rot/damage at deck edges

42. Rot/damage at deck edges

43. Rot/damage at deck edges

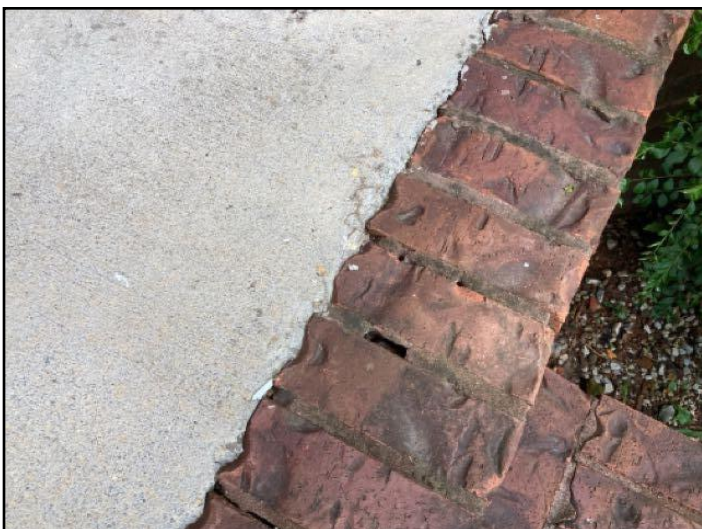
No major damage to the front porch concrete surface. There are some small gaps in the brick veneer and at an outer concrete corner. Seal any noticeable gaps as needed.

45. Brick gap

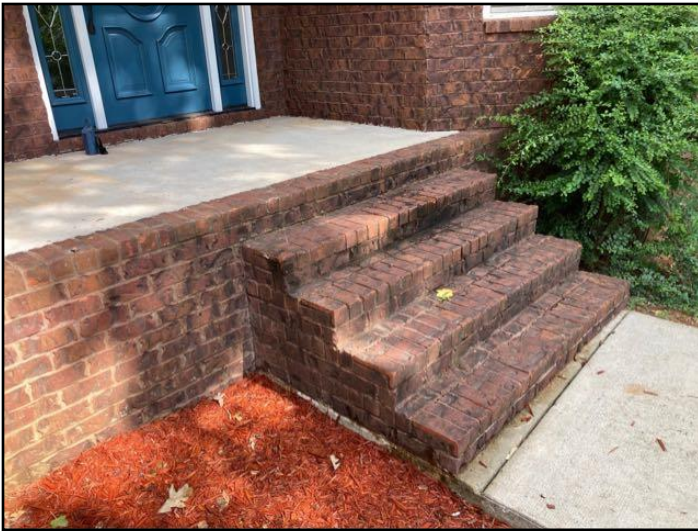
Handrails are typically required at stairs with four or more risers. The front porch stairs do not have a handrail installed. Guardrails are required at porches & decks that are over 30" above the ground. The front porch is taller than 30". Installing a handrail & guardrail is recommended.

47. Handrail missing

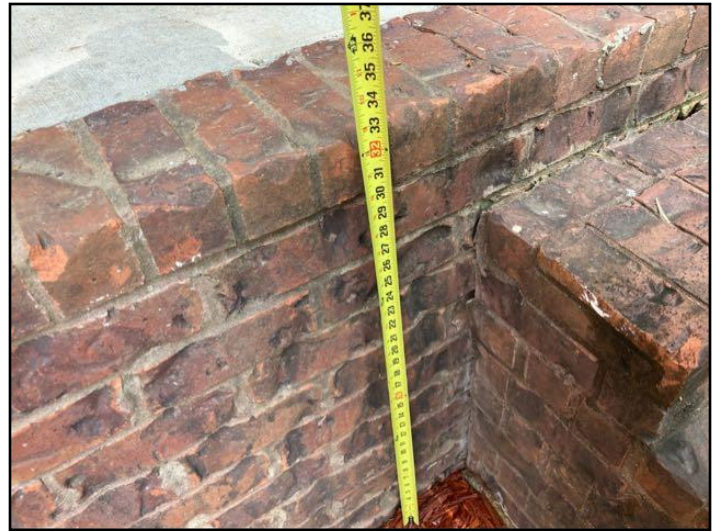
48. Porch height requires guardrail

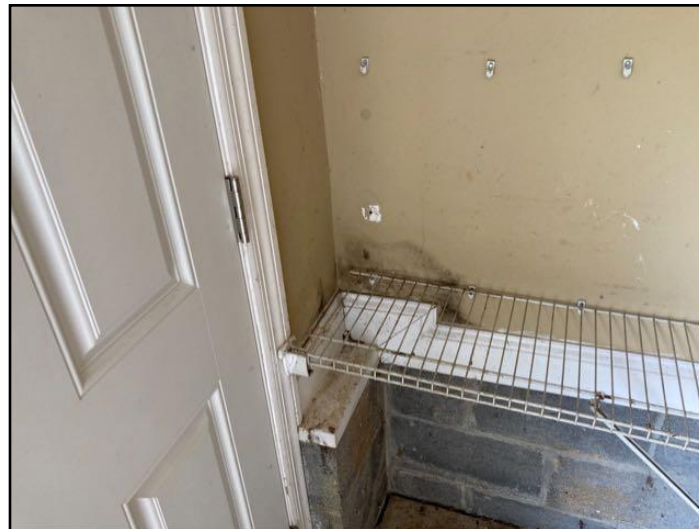
There are some dark stains on the drywall in the garage opposite the laundry room. This may be from previous spills or laundry area leaks. Monitor for further leaks. Clean the area to remove any potential mold/organic growth.

49. Wall stains

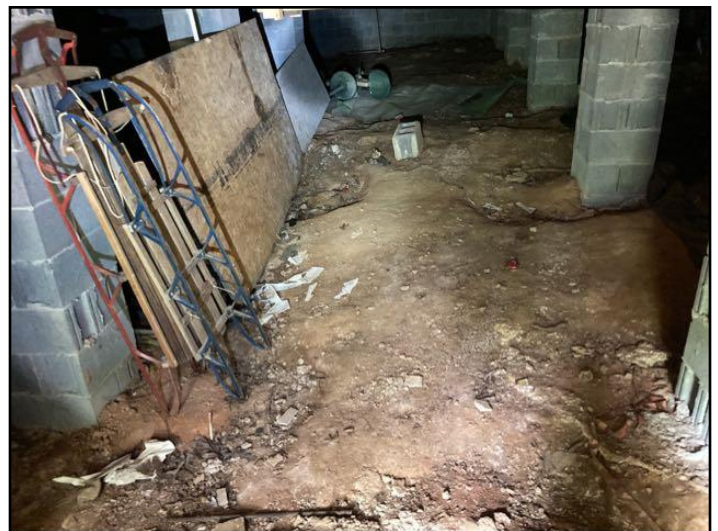
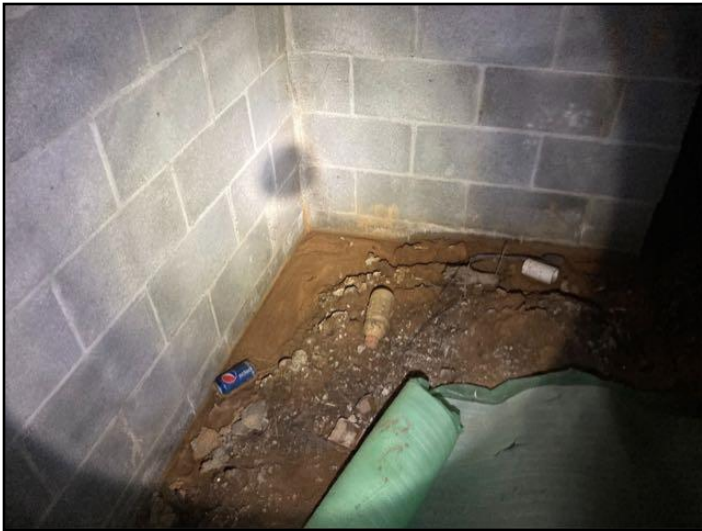
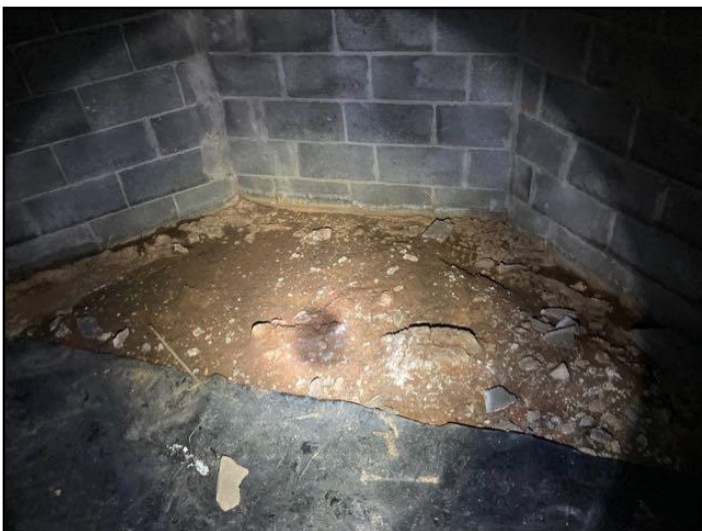
8.- The crawlspace vapor barrier has several large gaps, disheveled areas, and areas covered with sediment. Replacing the barrier or adding a new/fresh barrier is recommended. A complete and professionally installed barrier will improve the long-term ability of the crawlspace to remain dry and free from mold & fungal growth. Periodically check for moisture intrusion and plumbing leaks.

51. Vapor barrier missing

52. Vapor barrier missing

54. Vapor barrier missing

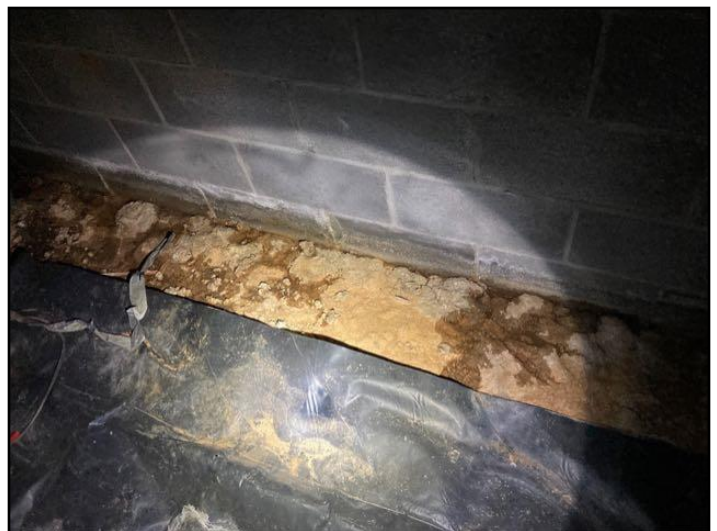
9.- Water was seeping in under the left side foundation wall. In most cases, I would presume that the moisture is from

ground water/exterior drainage. However, the water in the subject crawlspace is around the main plumbing drain line as it exits the house. Verify the plumbing is free from leaks. Improve exterior drainage to prevent ongoing moisture seepage. Monitor for excessive moisture & evaluate further if needed.

55. Water seepage at left side

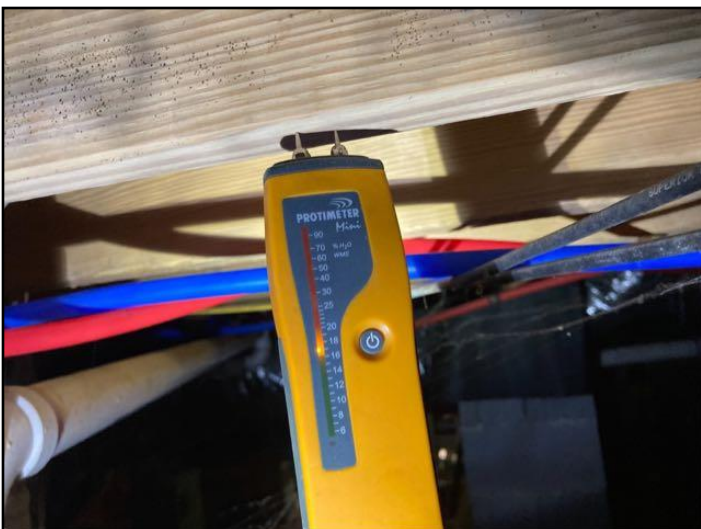
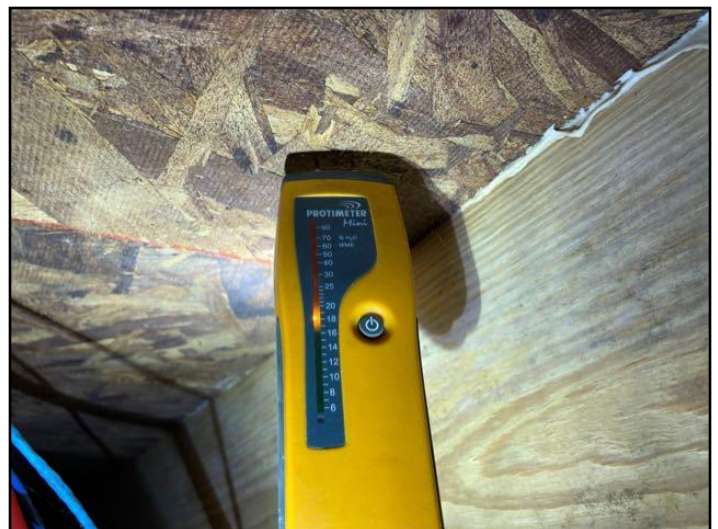
I placed a moisture meter on the floor joists and subfloor in various locations and found some borderline moisture content. Based on the condition of the vapor barrier and the warm air noted inside the crawlspace-- I would expect the moisture content level to increase in summer. Improving the vapor barrier and reducing moisture & condensation can prevent ongoing long-term issues with crawlspace moisture.

58. Borderline moisture content

59. Borderline moisture content

Monitor the crawlspace for leaks, condensation, and general signs of moisture. Improve or evaluate further if needed. Treat or remove any fungal growth as needed.

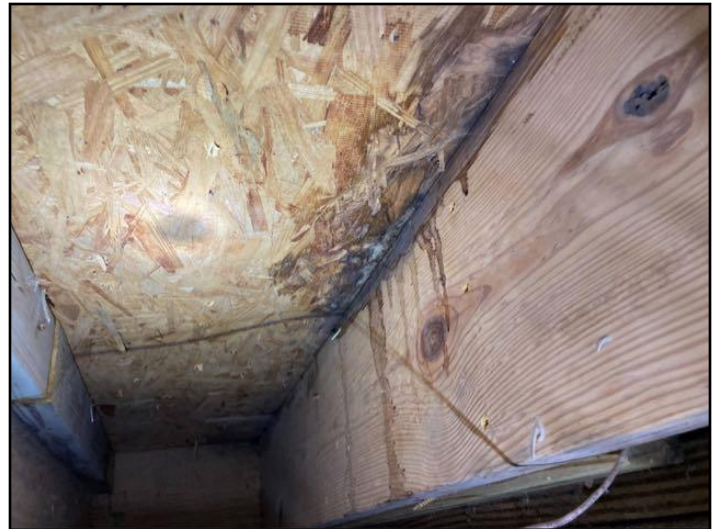
10.- There are water-stained areas & previous repairs under the rear exterior living room and rear exterior sunroom doors. Continued water intrusion at the doors is highly likely (see structural section for details). Ask the seller when the repairs occurred and what the repairs included. The doors should be evaluated further and improved to prevent continued moisture seepage & wood rot/ further damage. Sealing the exterior doors or adding pan flashing under the doors is recommended.

63. Water stains under rear living room door

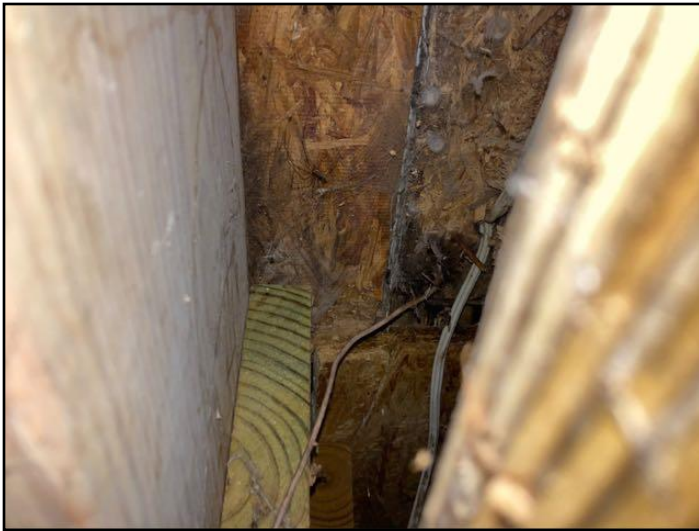
64. Stains/ wood damage under living room door

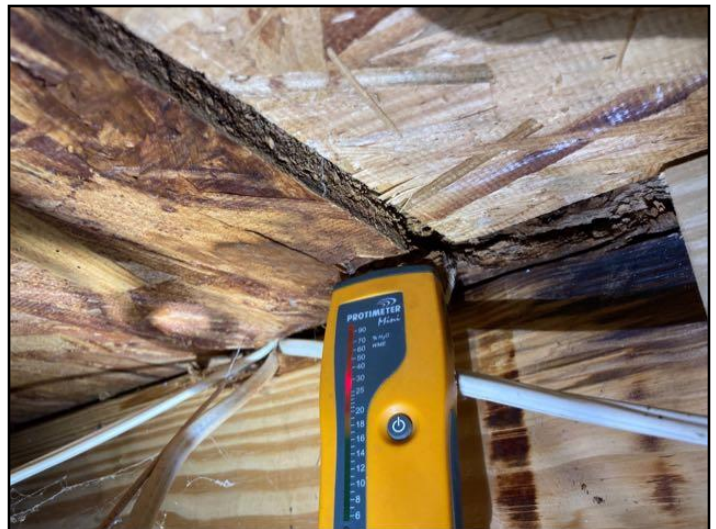
67. High moisture content under rear sunroom door

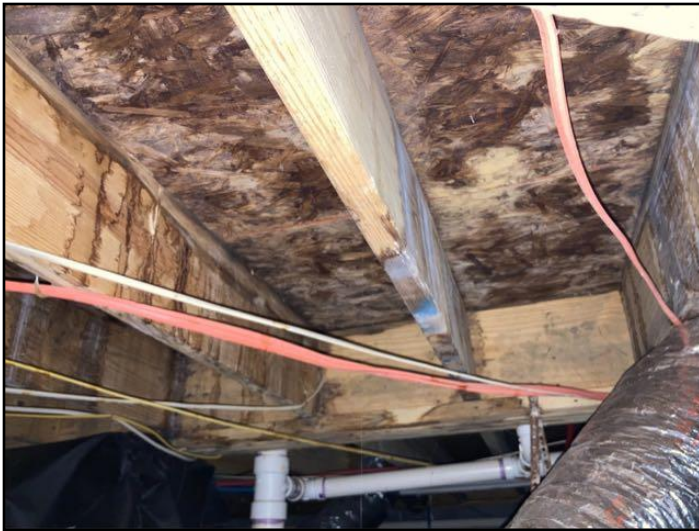
11.- I also noticed large water stains on the subfloor under the kitchen/living area (possible long-term refrigerator leak) and under the laundry room (possible washer plumbing leak). I recorded acceptable moisture content under the kitchen/living area and one borderline reading under the laundry room. Ask the seller if they are aware of previous leaks in these areas. Evaluate or improve further if needed.

68. Large water stains under kitchen/living room

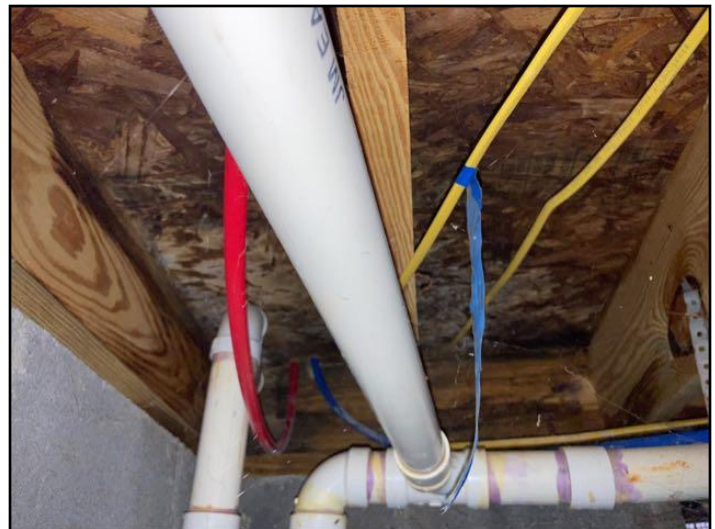
71. Large water stain under laundry room

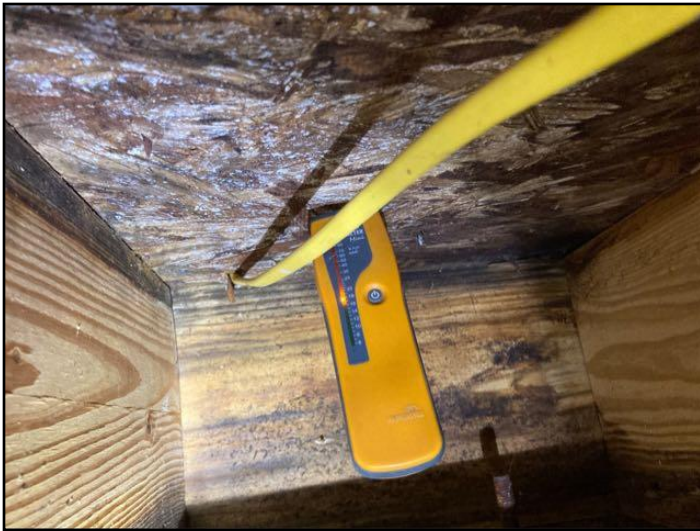
72. Borderline moisture content under laundry

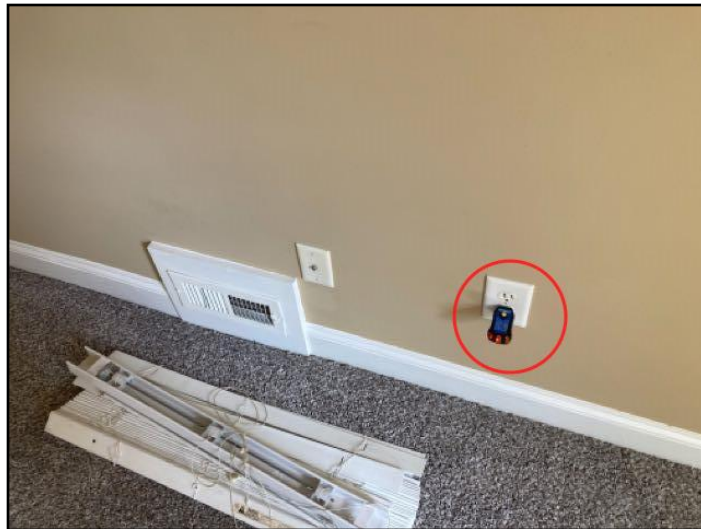
12.- One electrical outlet in the upper-level bonus room has reversed polarity. Re-wire/ repair the outlet.

76. Reversed polarity

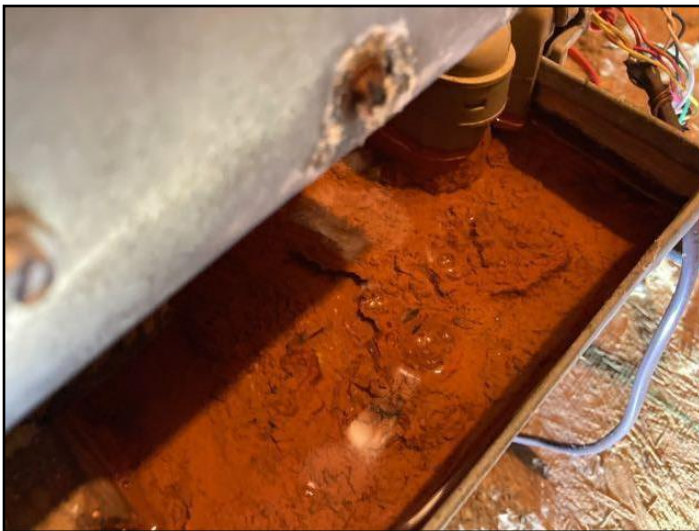
14.- The HVAC air handler for the upper level is located inside the attic. The unit has a drain pan and float switch to limit spills/leaks. The drain pan for the unit is nearly halfway filled with water and the pan appears rusty. Under normal conditions, the pan should always be dry. The water and rust indicate that the HVAC system should be evaluated/serviced by an HVAC technician or contractor. Verify the age of the systems (questionable manufacture dates) and any recent service records.

79. Water/rust in pan

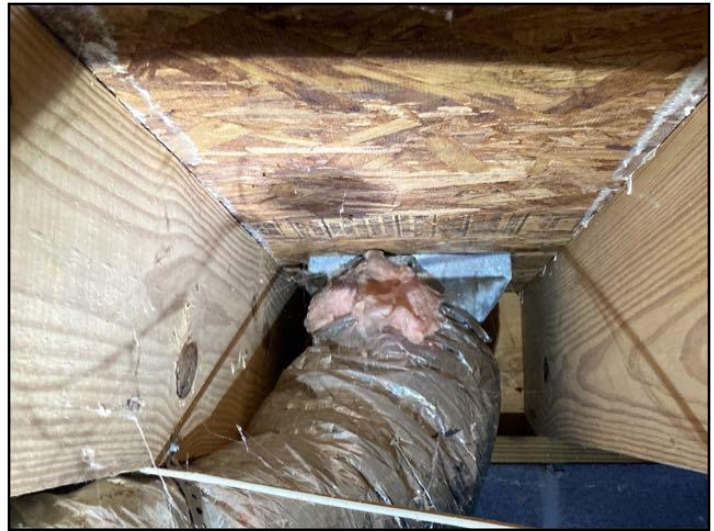
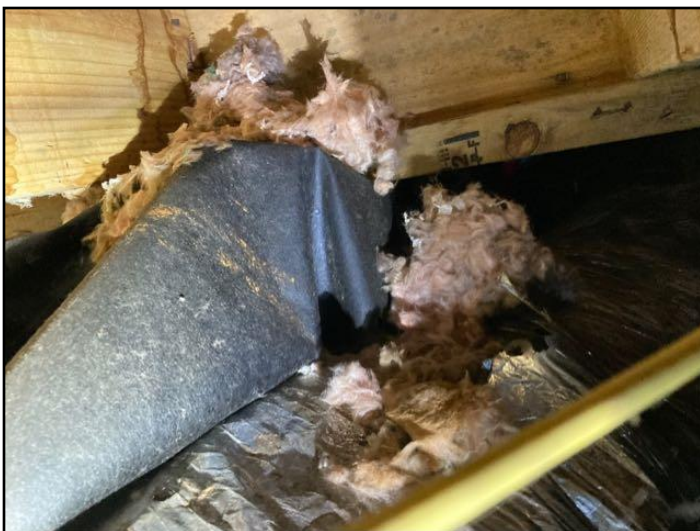
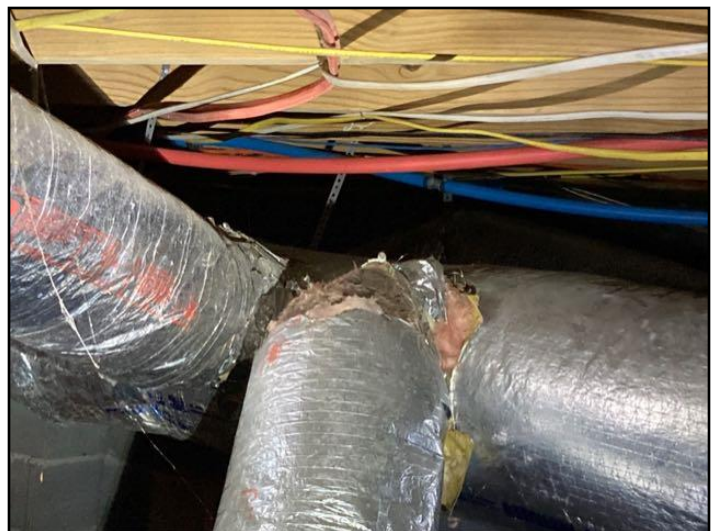
13.- The HVAC ductwork in the crawlspace has some leaking areas due to duct holes/ openings. One duct is completely disconnected near the center of the crawl. One duct has a noticeable rodent hole. Additional ducts have damaged insulation or are not fully supported. The ducts (including the attic ducts) should be evaluated for repair or replacement. Cleaning the duct interiors is also recommended unless the ducts are completely replaced.

87. Damaged insulation

88. Damaged insulation

89. Damaged insulation

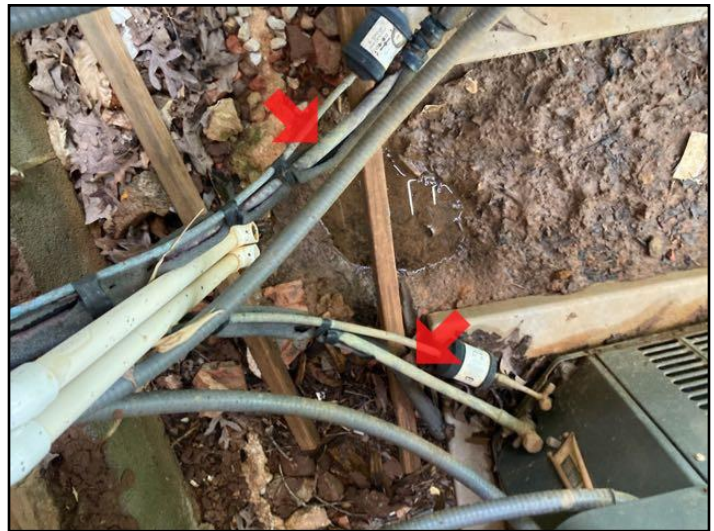
The HVAC condensers are not level. This can damage the internal components over time. Re-level the units. The insulation is missing or damaged at the exterior low-pressure refrigerant lines. Replace the insulation.

96. Insulation missing

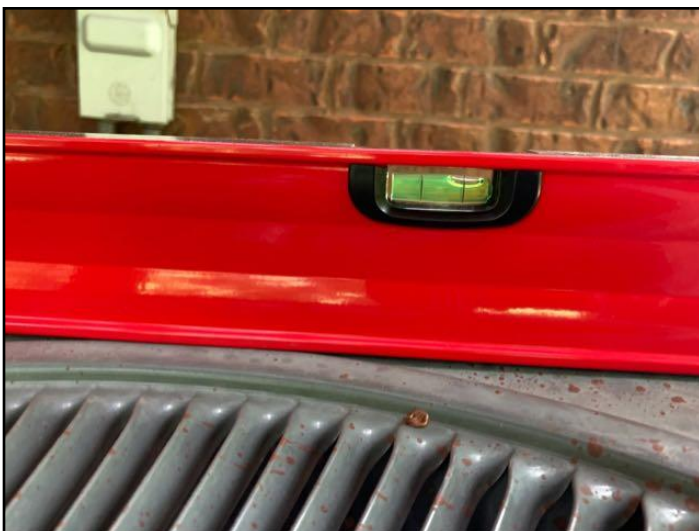
97. Condenser not level

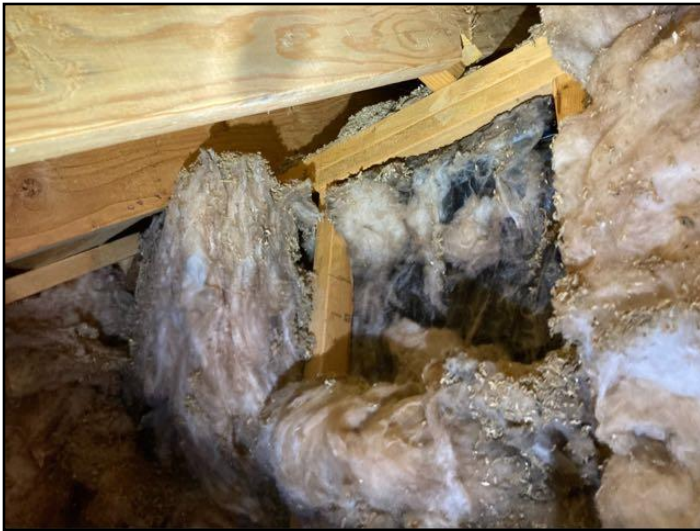
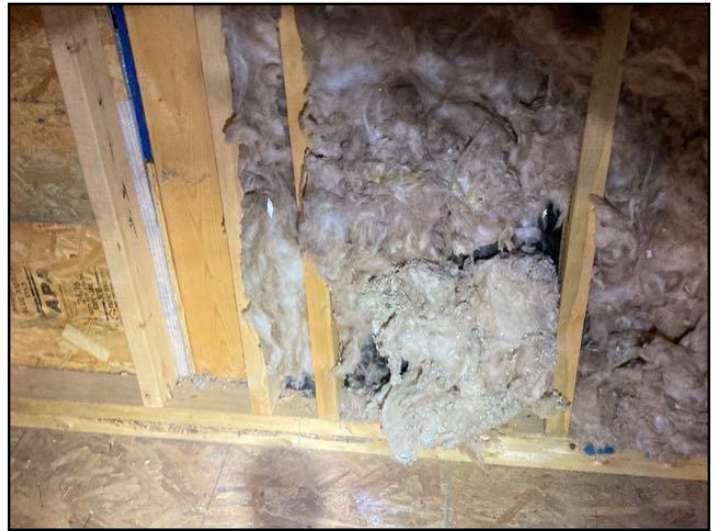
106. Damaged insulation

107. Damaged insulation

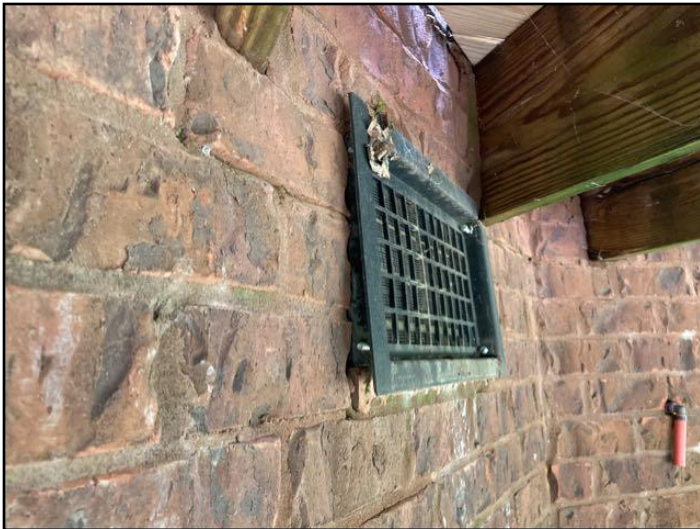
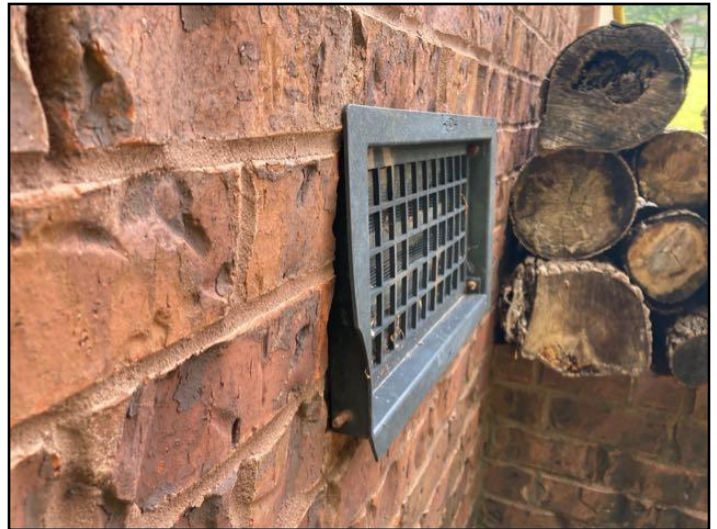
Some of the foundation vents are loose at the exterior brick. Secure/re-position the vents where needed.

108. Loose vent

109. Loose vent

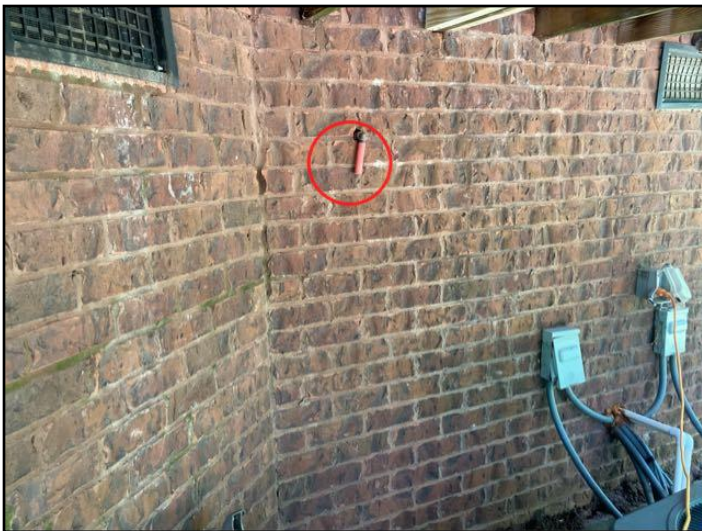
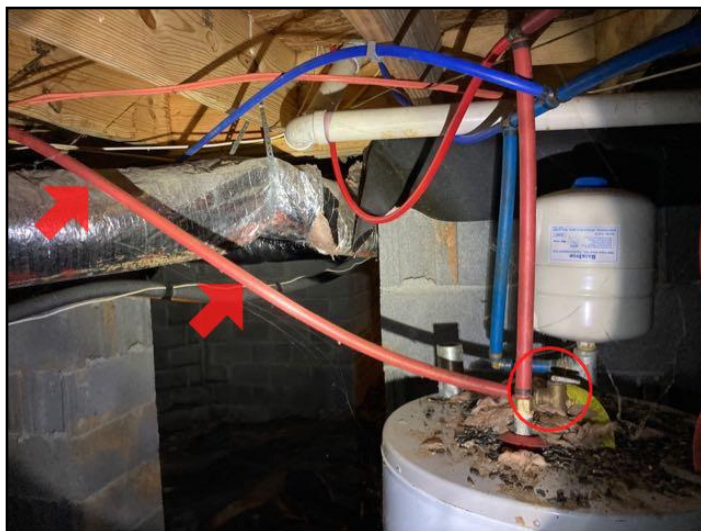
17.- The water heater pressure relief valve is improperly routed against gravity. Water heater manufacturers and safety standards require the tube to flow with gravity. Additionally, the tube terminates too high above the ground. The discharge point should be within 6" of the ground to limit the spray of any scalding water/discharge. Adjust/re-position the discharge tube.

111. Improper discharge location/height

113. Improper relief valve discharge tube

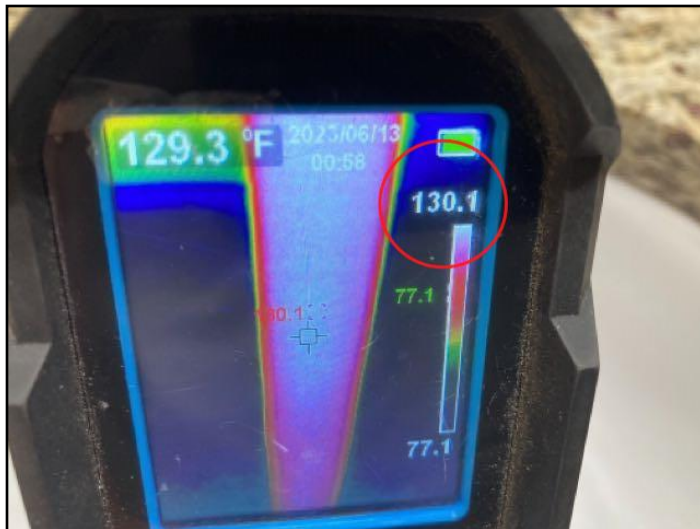
The hot water temperature was 130 degrees. This is above the recommended residential hot water temperature. Reducing the water temperature to 120 or lower is recommended.

114. Hot water temperature

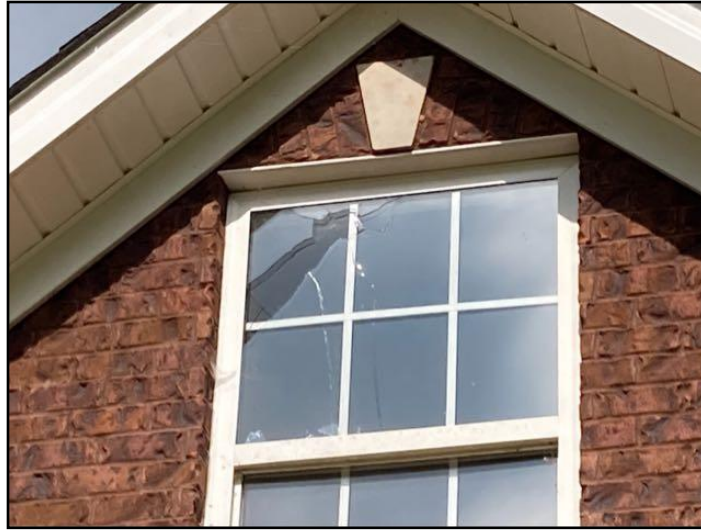
The upper level (front left) bonus room window has broken glass. Replace the window.

118. Broken glass

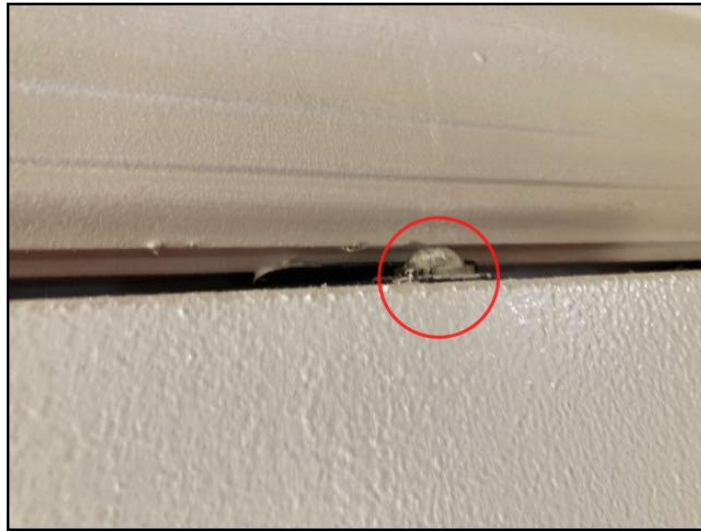
119. Ball latch too high

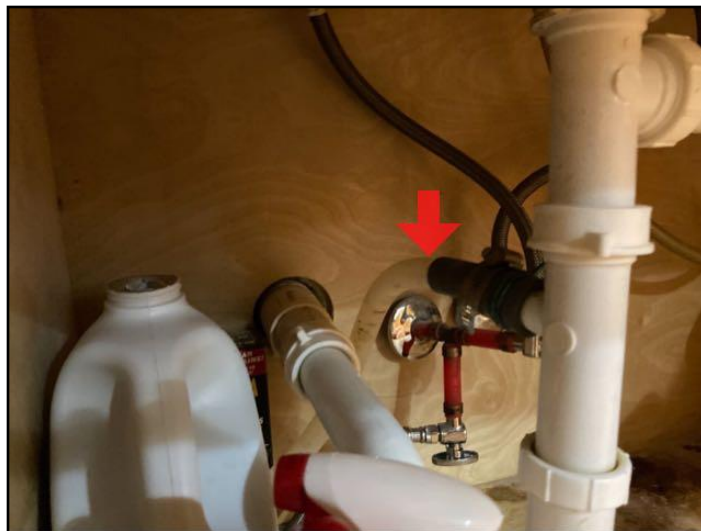
The dishwasher drain line should be raised above the sink bottom to prevent siphoning--backflow into the dishwasher.

120. Backflow prevention missing
