INSPECTION REPORT

For the Property at:
MEMORY LANE
HARVEST, AL 35749

Prepared for: HOME BUYER
Inspection Date: Monday, June 12, 2023
Prepared by: Steve Wehrman, AL-4164

RE: Report No. 2352, v.2
Memory Lane
Harvest, AL
35749

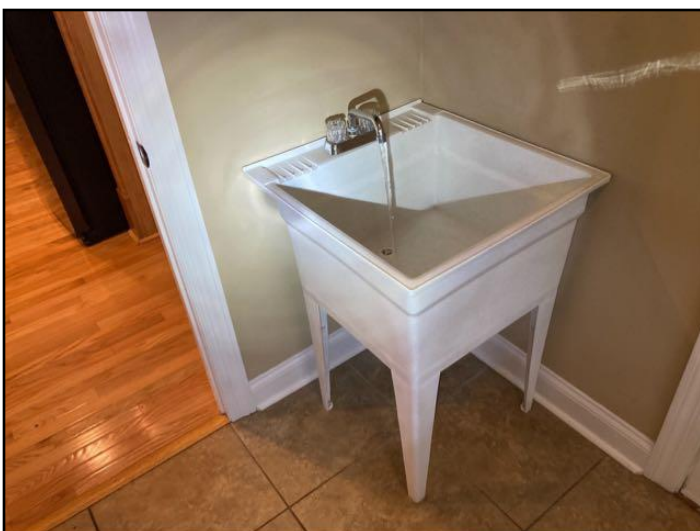
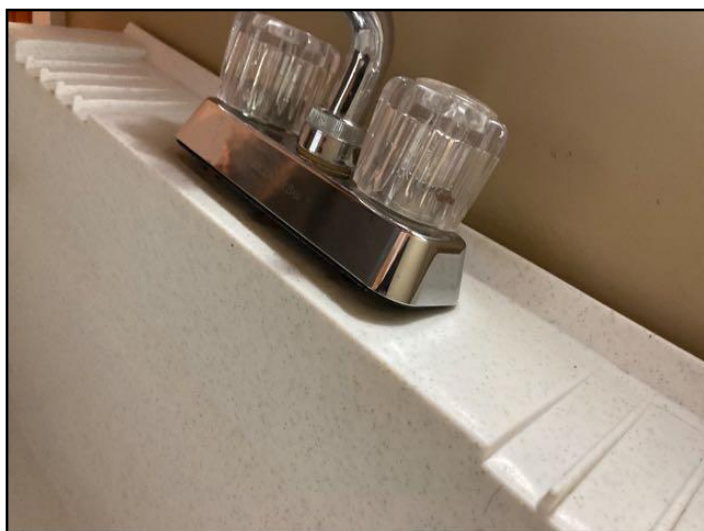
The laundry tub is not secured to the floor or wall and can be moved easily. Additionally, the sink faucet is not secured to the sink. Securing the sink is recommended.

121. Laundry tub

122. Loose faucet

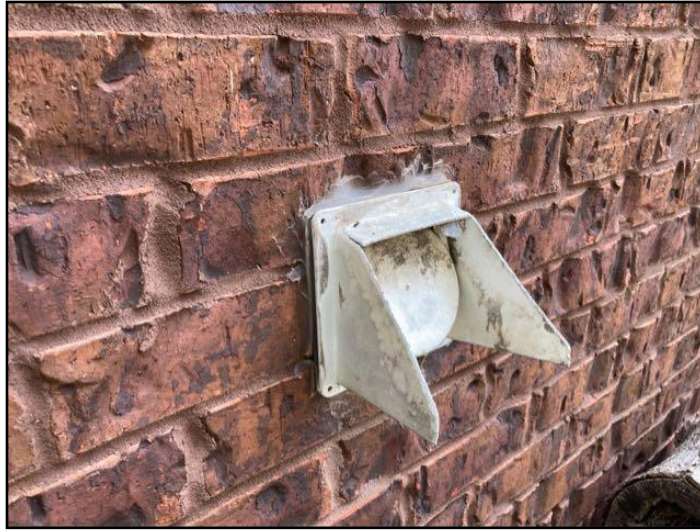
22.- The exterior dryer vent cover is damaged or partly missing. Replace the outer cover.

123. Damaged vent cover

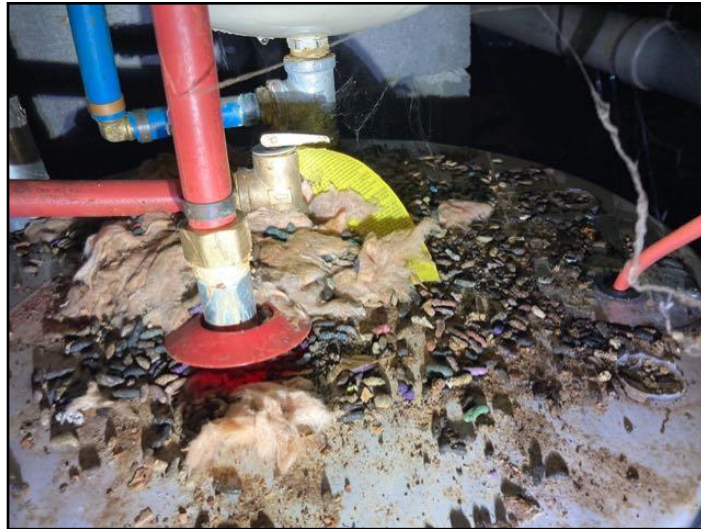
Evidence of previous rodent activity was found in the home (insulation tunnels in attic, tunnels into crawlspace ductwork, droppings on water heater). Ensure the home is regularly inspected and/or treated for pests.

126. Rodent droppings on water heater (crawlspace)

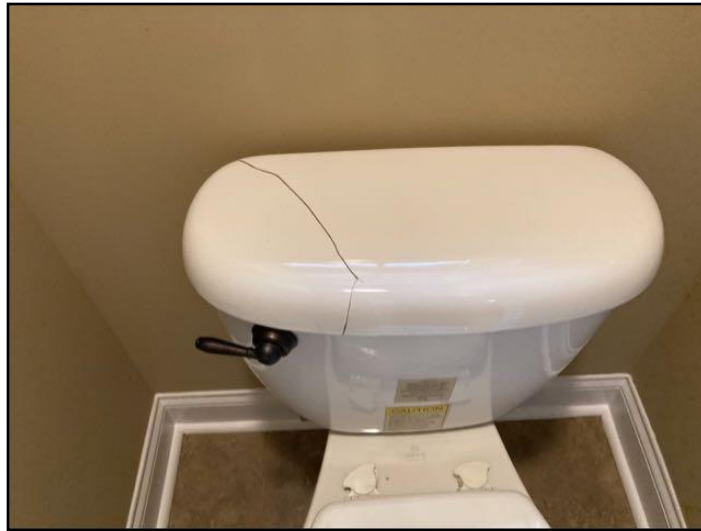
25.- The master bathroom toilet tank lid is cracked/damaged. Replace the lid.

137. Cracked tank lid

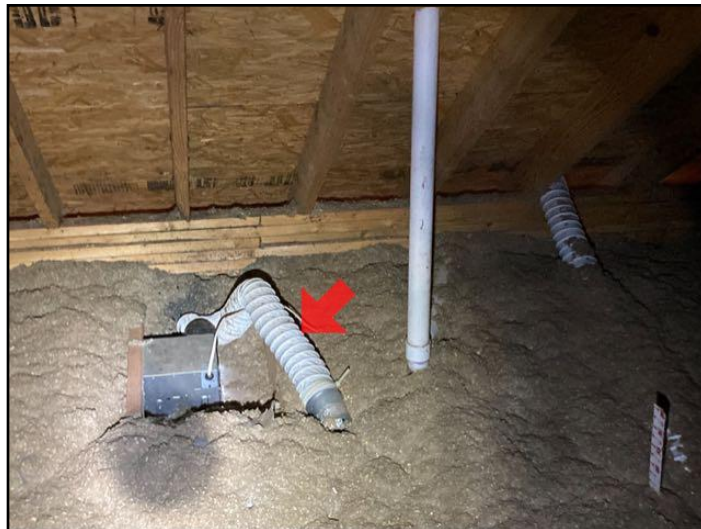
The upper-level bathroom vent fan did not turn on. Verify the fan is functional. Repair/replace as needed. I did not see a vent fan in the master bathroom except in the toilet area/ water closet. Vent fans are primarily used to remove steam and humidity. Consider installing a vent fan in the main area of the master bathroom. One vent fan discharge tube is disconnected inside the right side attic. Reattach the vent tube. Verify all vent fans discharge to the exterior or to the roof vents.

138. Fan exhaust tube detached
