INSPECTION REPORT

For the Property at:
MEMORY LANE
HARVEST, AL 35749

Prepared for: HOME BUYER
Inspection Date: Monday, June 12, 2023
Prepared by: Steve Wehrman, AL-4164

RE: Report No. 2352, v.2
Memory Lane
Harvest, AL
35749

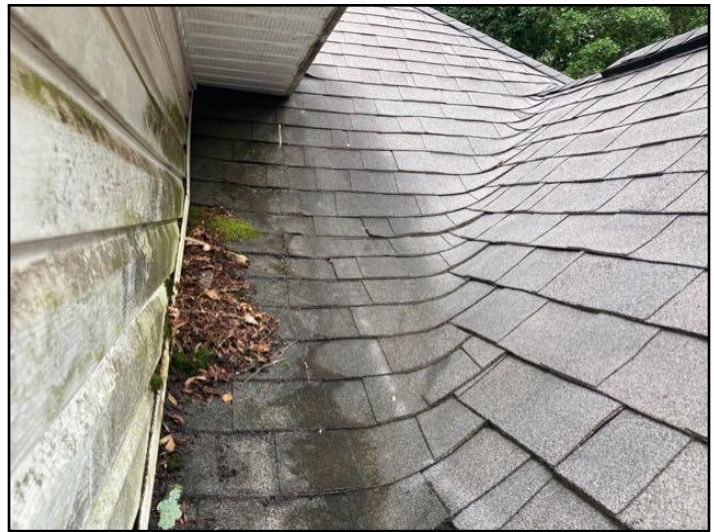
2. Debris/ moss growth

1.- There is a nail pop through the shingles above the front porch. Seal/repair any exposed nails. Some moss growth and some branches/leaves noted atop the roof. Periodically remove any debris, moss, & organic growth.

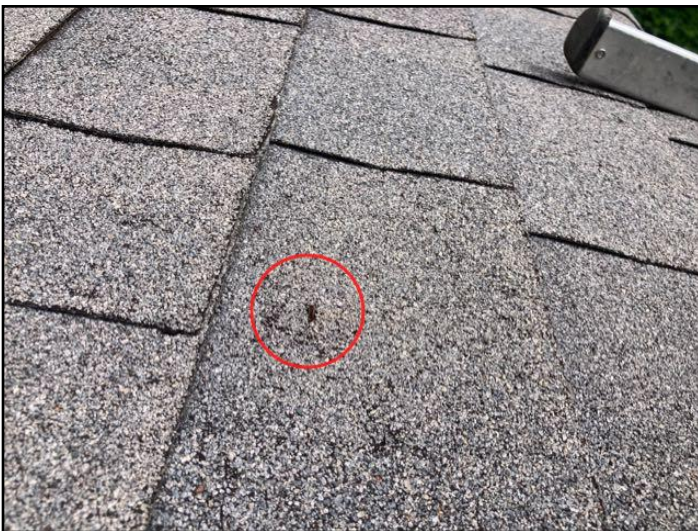
3. Nail pop at front center

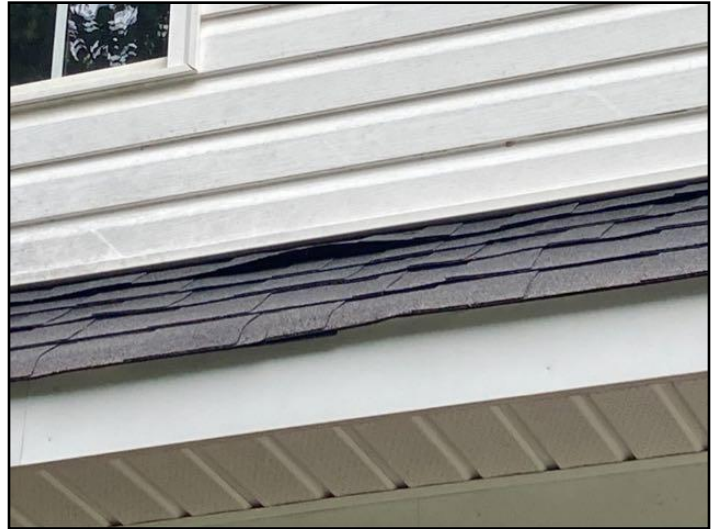
8. Shingle or flashing uplift

2.- The sidewall roof flashing above the front porch has a loose or uplifted area. There is also an uplifted shingle or flashing area in front of the left side dormer. Secure the flashing where needed. There are some caulking gaps at the front sidewall flashing (above the porch). Touch-up or re-caulk where needed.

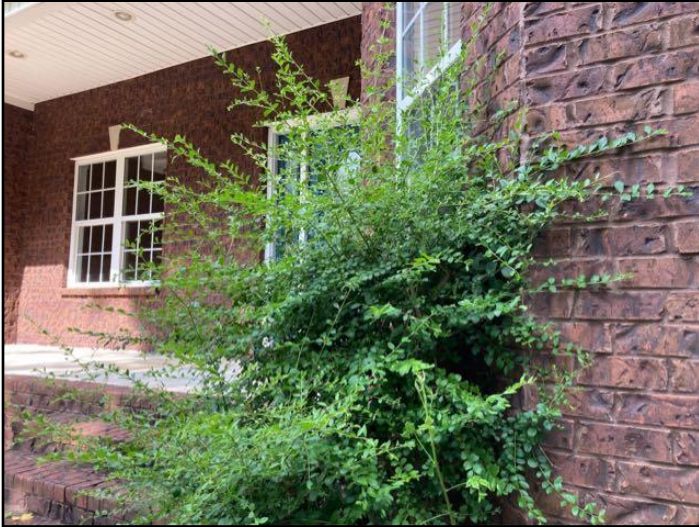
Some of the trees and landscaping are overgrown. Trim any trees/landscaping that are in contact with the house and roof.

13. Overgrown landscaping

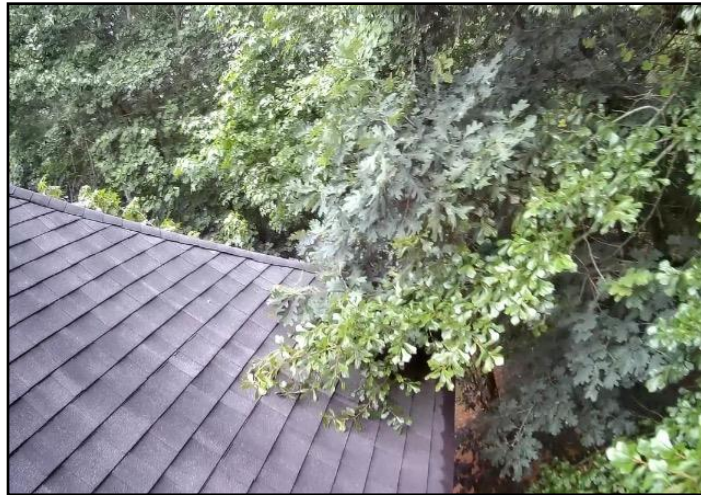
15. Tree branch/ roof contact

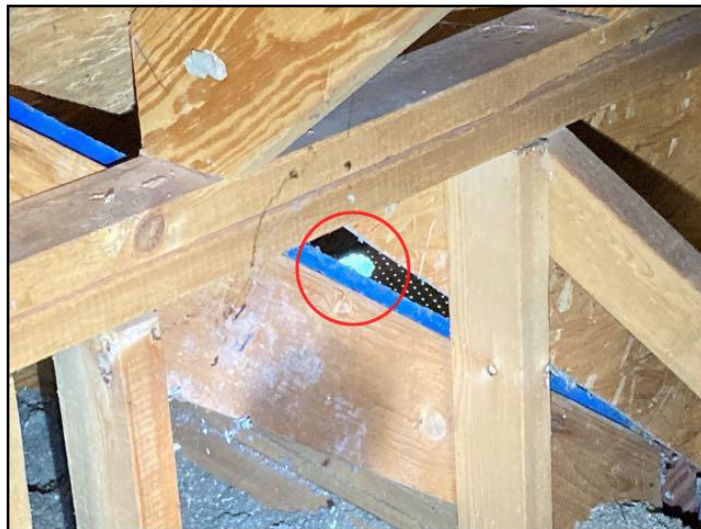
18. Hole in soffit

4.- There is a hole in the right side soffit (likely caused by a squirrel). The hole can allow squirrels & other pests access into the attic. Seal/repair any holes in the soffits. Some of the vinyl soffit coverings have popped out of place. Secure where needed.

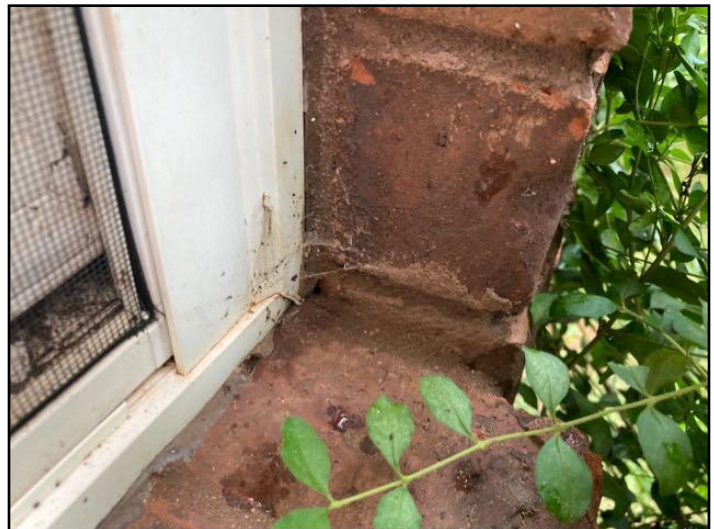
20. Caulking/mortar gap

6.- There are some minor gaps in the exterior brick mortar/caulk at the exterior windows & wall penetrations. Caulk/seal any noticeable gaps at the brick veneer. One small loose brick was noted above a rear foundation vent. Secure/repair the loose brick.

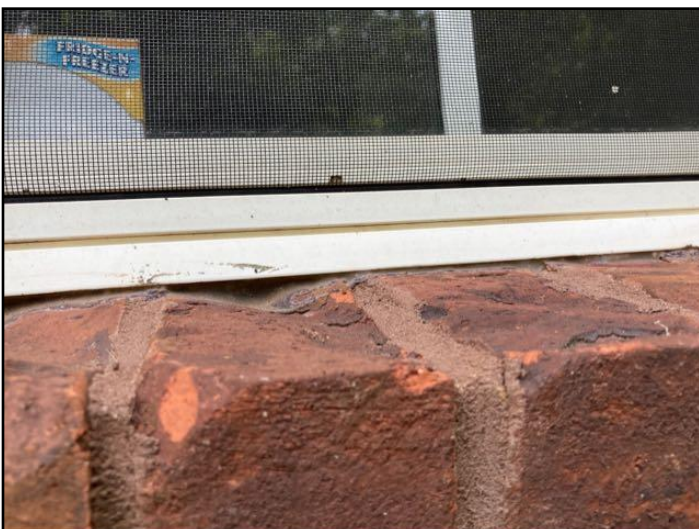
21. Caulking/mortar gap

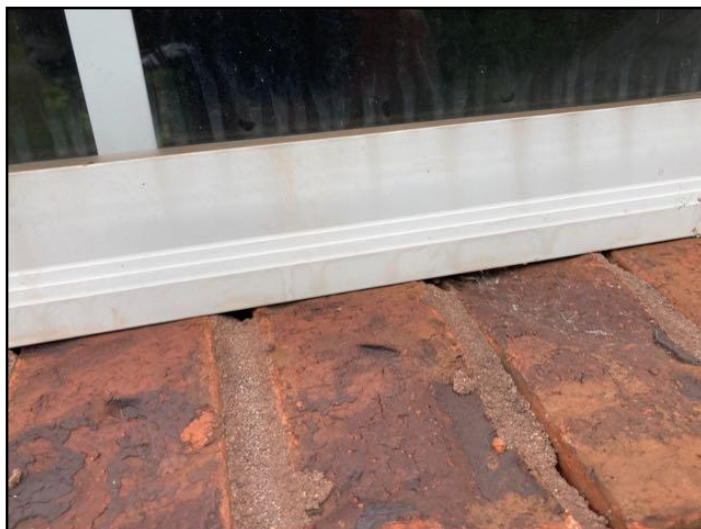
26. Caulking gap

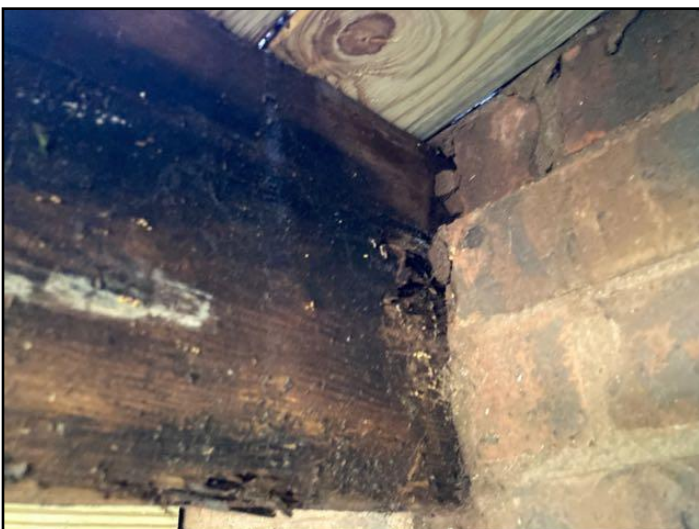
30. Soft wood

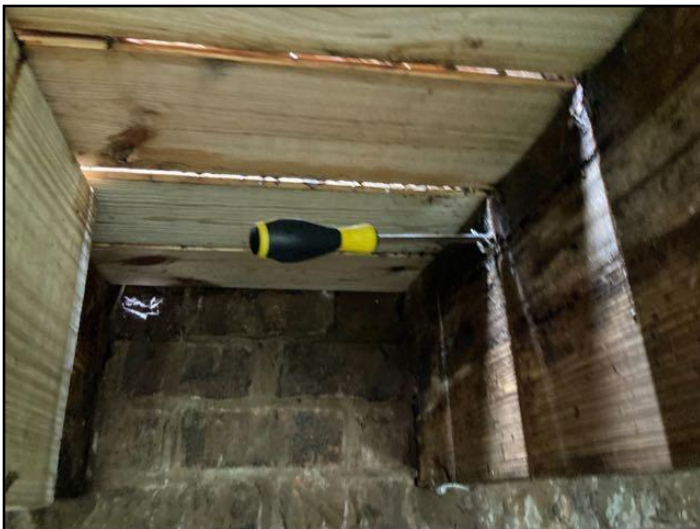
34. Soft wood

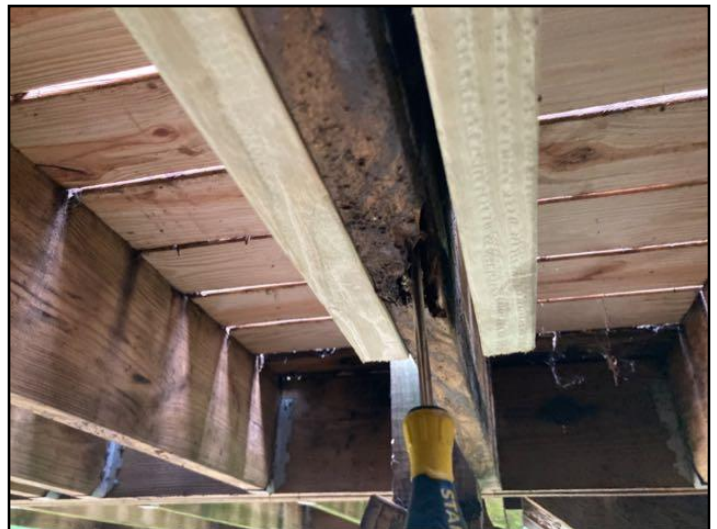
35. Soft wood

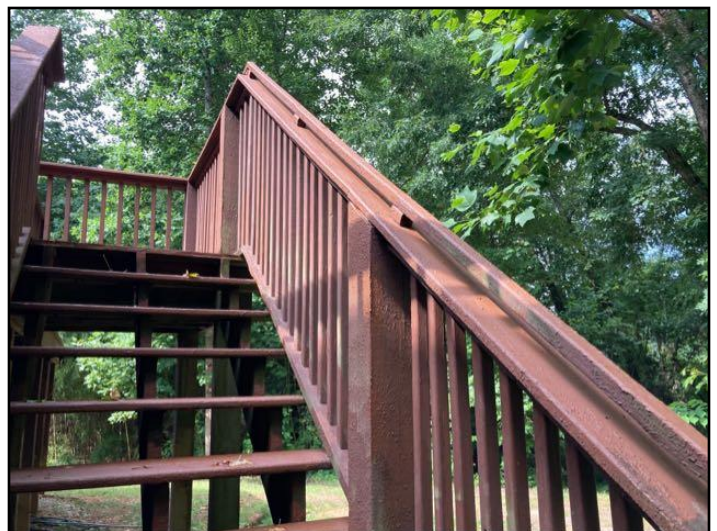
39. Questionable top rail

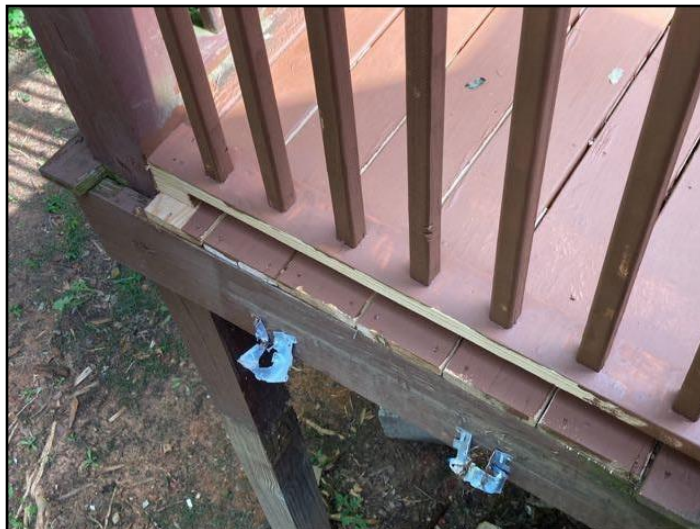
44. Uneven paint

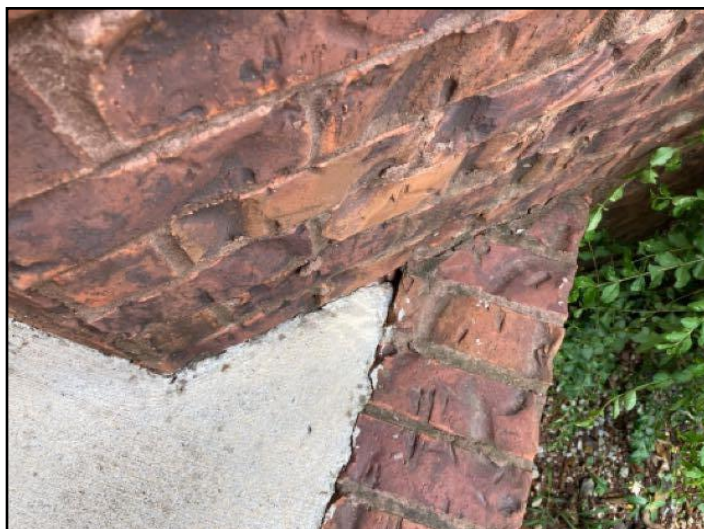
46. Concrete gap

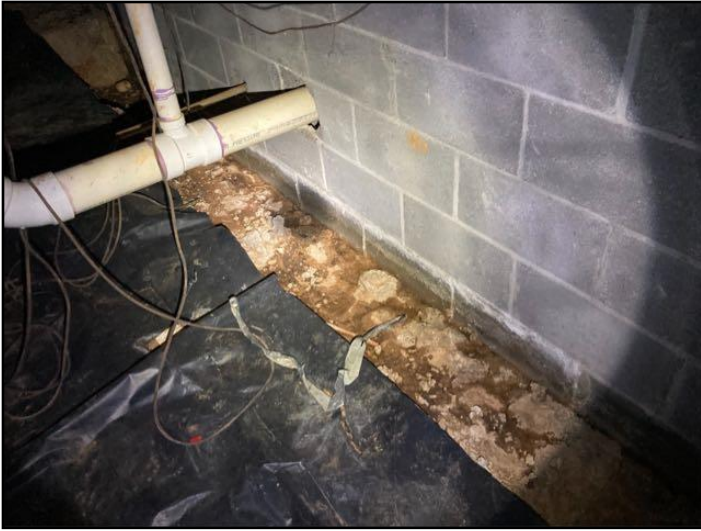
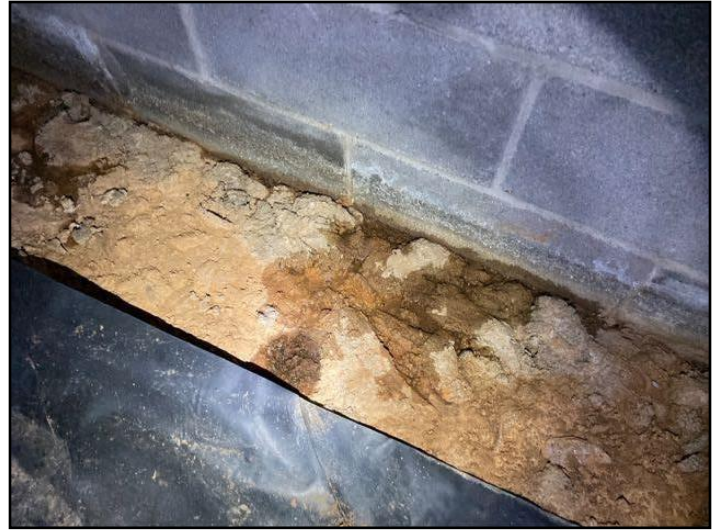
9.- Water was seeping in under the left side foundation wall. In most cases, I would presume that the moisture is from

ground water/exterior drainage. However, the water in the subject crawlspace is around the main plumbing drain line as it exits the house. Verify the plumbing is free from leaks. Improve exterior drainage to prevent ongoing moisture seepage. Monitor for excessive moisture & evaluate further if needed.

56. Water seepage at left side

57. Water seepage at left side

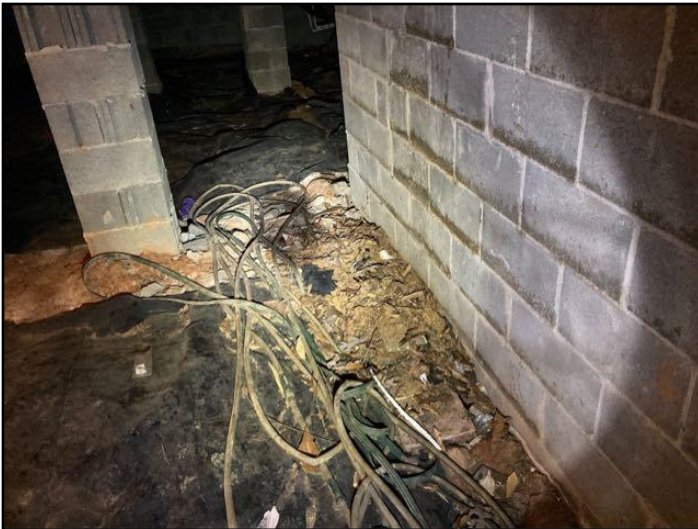
62. Debris under rear door

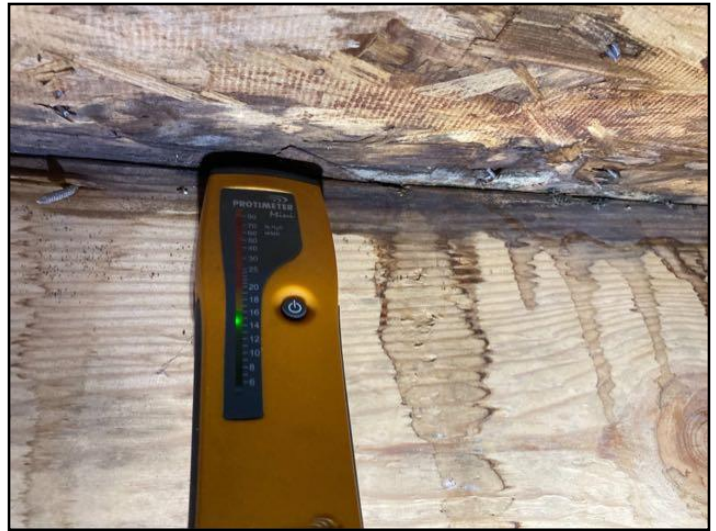
65. Acceptable moisture content under living room

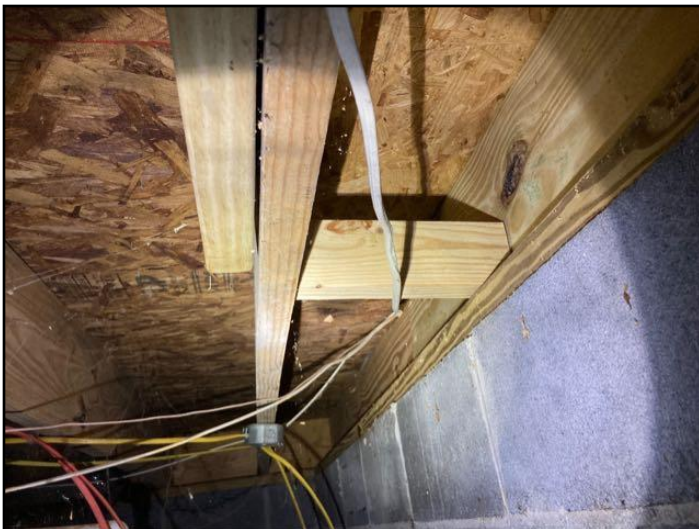
10.- There are water-stained areas & previous repairs under the rear exterior living room and rear exterior sunroom doors. Continued water intrusion at the doors is highly likely (see structural section for details). Ask the seller when the repairs occurred and what the repairs included. The doors should be evaluated further and improved to prevent continued moisture seepage & wood rot/ further damage. Sealing the exterior doors or adding pan flashing under the doors is recommended.

66. Repairs under rear sunroom door

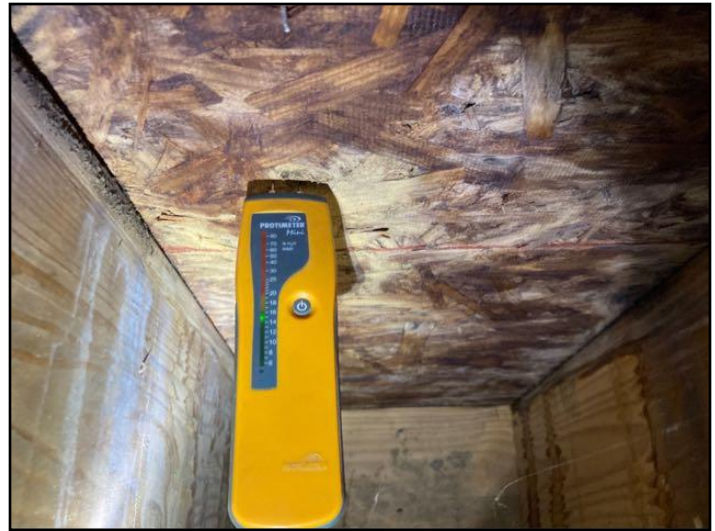
69. Acceptable moisture content under kitchen

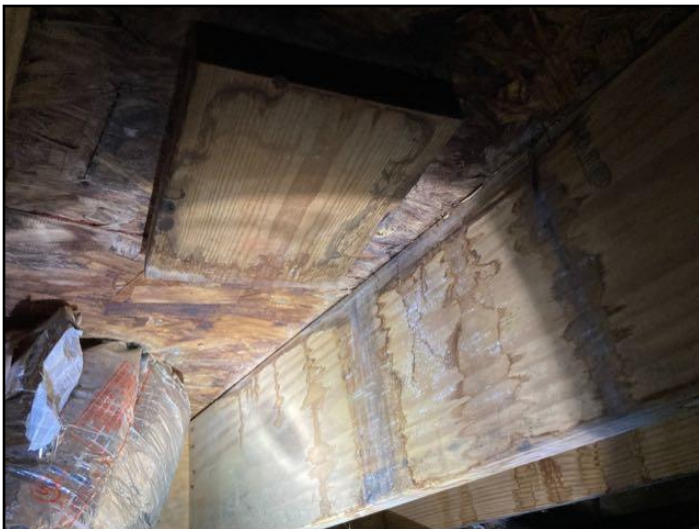
11.- I also noticed large water stains on the subfloor under the kitchen/living area (possible long-term refrigerator leak) and under the laundry room (possible washer plumbing leak). I recorded acceptable moisture content under the kitchen/living area and one borderline reading under the laundry room. Ask the seller if they are aware of previous leaks in these areas. Evaluate or improve further if needed.

70. Patch repair under living/kitchen area

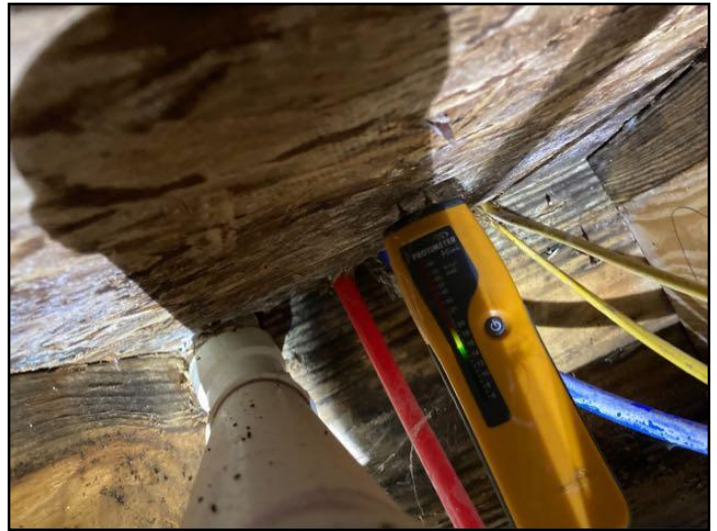
73. Acceptable moisture content under laundry

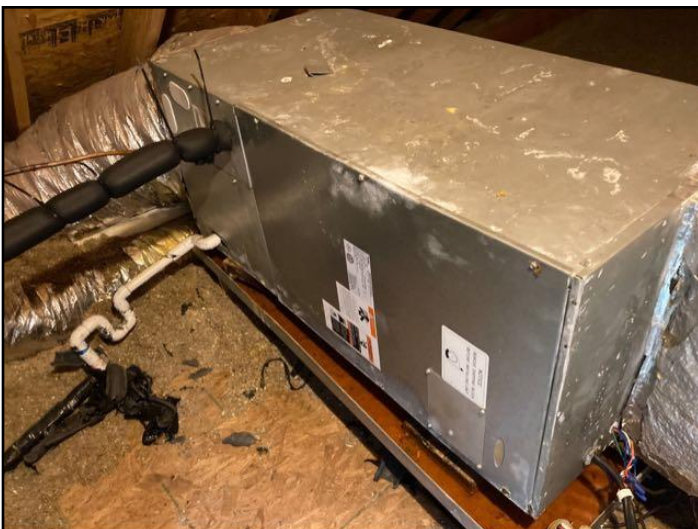
The HVAC air handler for the upper level is located inside the attic. The unit has a drain pan and float switch to limit spills/leaks. The drain pan for the unit is nearly halfway filled with water and the pan appears rusty. Under normal conditions, the pan should always be dry. The water and rust indicate that the HVAC system should be evaluated/serviced by an HVAC technician or contractor.

77. HVAC air handler (upper)

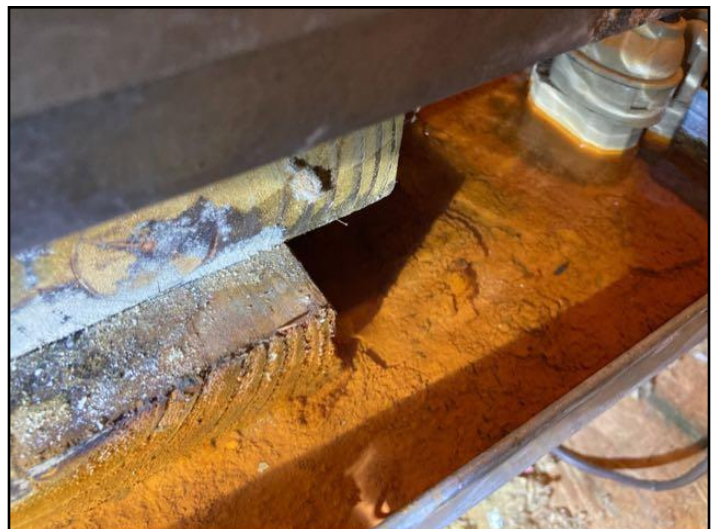
78. Water in pan

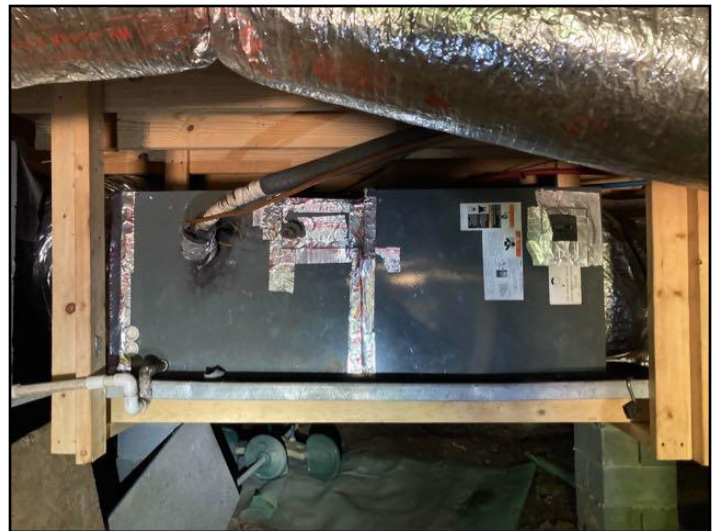
The HVAC air handler for the main level is located in the crawlspace. The unit has a drain pan. I did not see a float switch or spill protection device. In most cases, spill protection devices are not installed in crawlspaces. Monitor for condensate leaks/spills. Service the system 1-2 times per year.

80. HVAC air handler (lower)

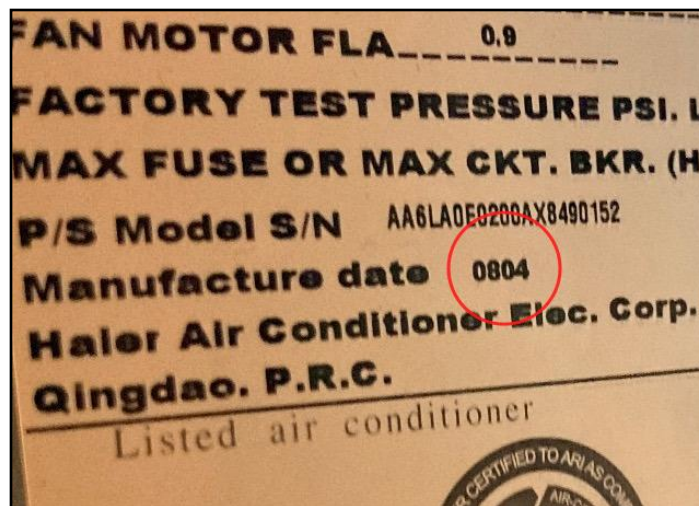
An additional note--the HVAC brand (Haier) is not one I typically see. According to the manufacturer labels, the upper-level HVAC air handler was manufactured in "0804". I would interpret this as being manufactured in August 2004. This seems odd since the home was built in 2011. The crawlspace air handler manufacture date reads "0908" which I would interpret as September 2008. Verify the manufacture date of the HVAC systems and any recent service records if possible.

81. Manufacture date for upper air handler

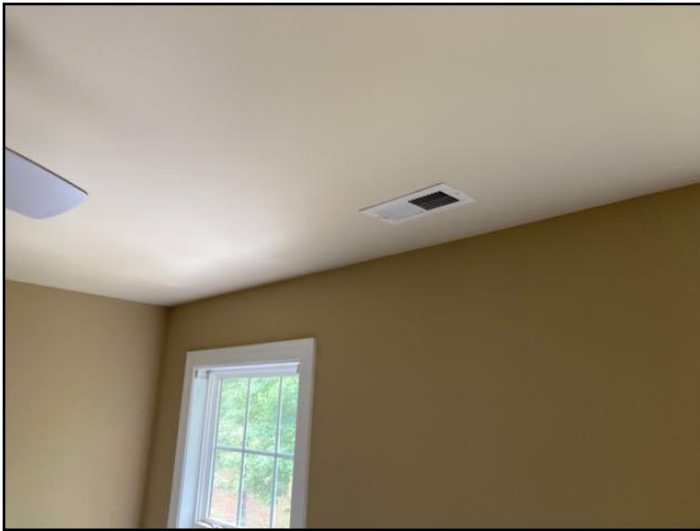
82. Weak performance at supply register

In cooling mode, an 18-21 degree temperature differential was recorded between the air returns and the registers. Some poor performance noted at supply registers with damaged ductwork (see heating section). Repairing/ improving the ductwork is recommended.

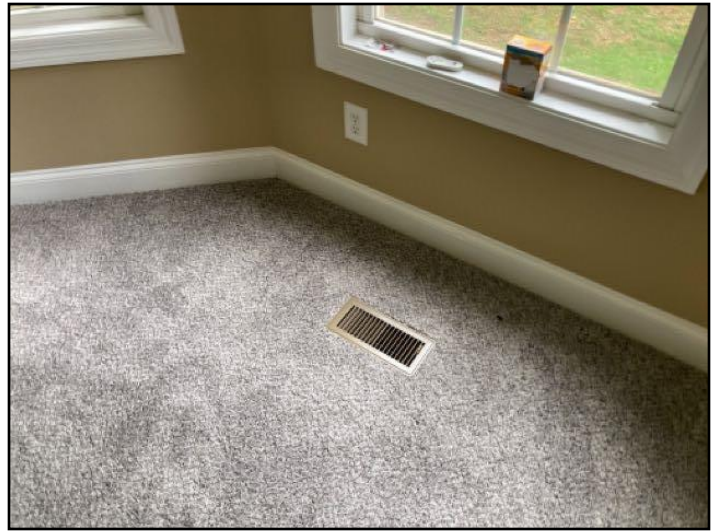
83. Weak performance at supply register

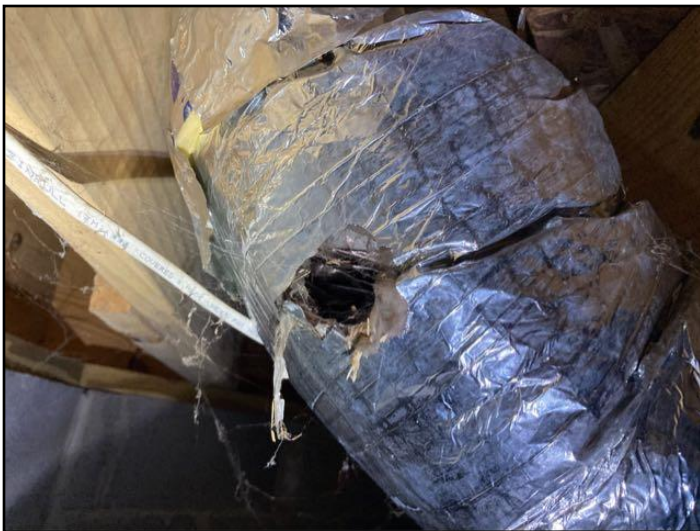
The HVAC ductwork in the crawlspace has some leaking areas due to duct holes/ openings. One duct is completely disconnected near the center of the crawl. One duct has a noticeable rodent hole. Additional ducts have damaged insulation or are not fully supported. I noticed two registers in the house with noticeably poor performance/flow. One is in the upper left bedroom--indicating there may be duct damage in the attic that was not obvious during the inspection. The front right main level bedroom's poor performance is likely due to the rodent hole & disconnected duct. The ducts should be evaluated for repair or replacement. Cleaning the duct interiors is also recommended unless the ducts are completely replaced.

84. Rodent tunnel in duct

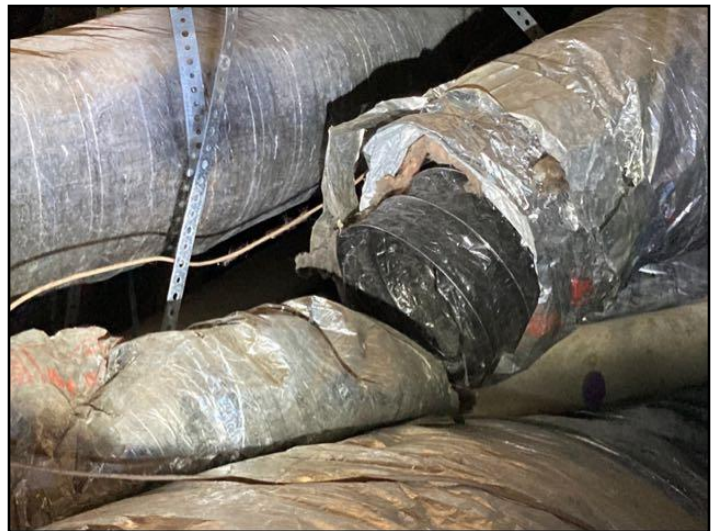
85. Disconnected duct

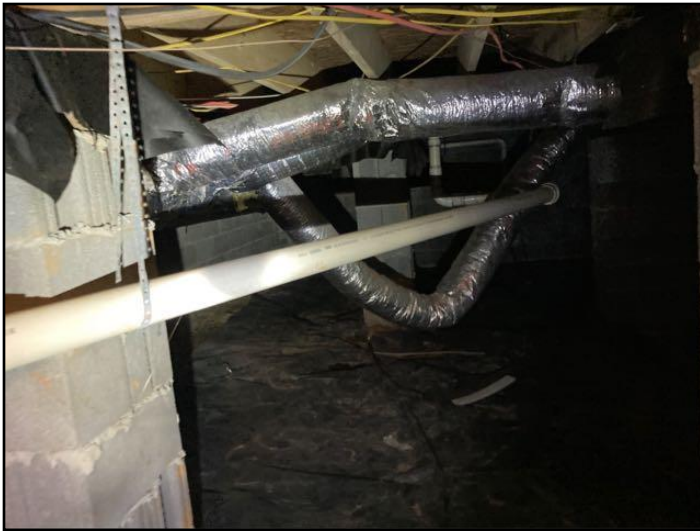
86. Sagging duct

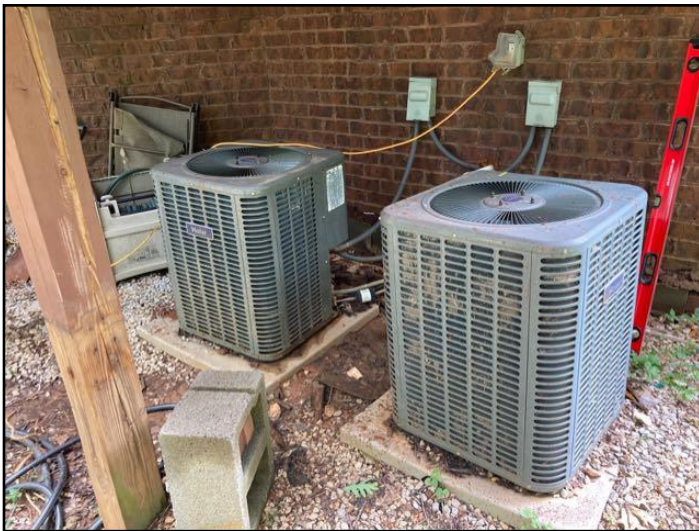
The manufacturer labels for the HVAC condensers are missing or not complete. I could not verify the age of the units. Based on the HVAC air handler's manufacturer information and the age of the house, the condensers may have manufacturer dates between 2004 & 2011. Verify any information about the HVAC systems if possible.

95. HVAC condensers

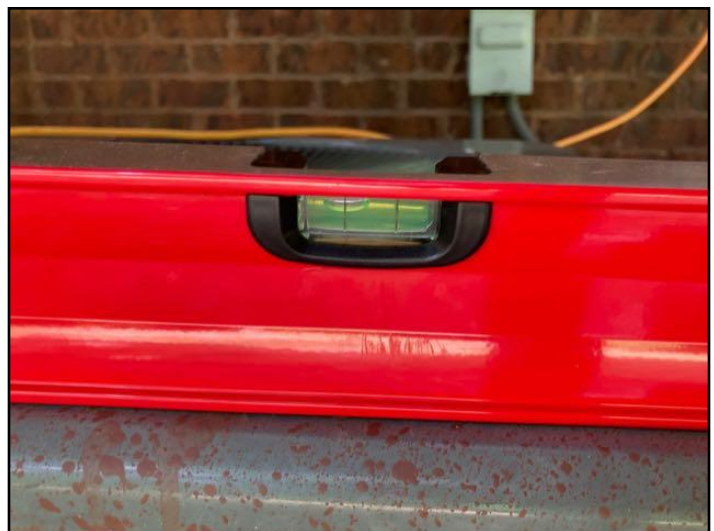
The HVAC condensers are not level. This can damage the internal components over time. Re-level the units. The insulation is missing or damaged at the exterior low-pressure refrigerant lines. Replace the insulation.

98. Condenser not level

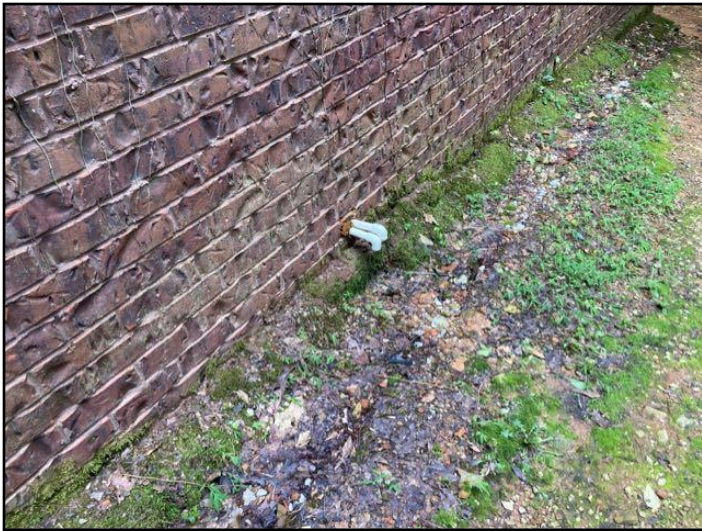
The condensate discharge points are next to the exterior HVAC condenser and in the right side yard. A water puddle & muddy conditions noted at the discharge location near the condensers. Extend or adjust the discharge point to improve perimeter drainage.

103. Condensate discharge location

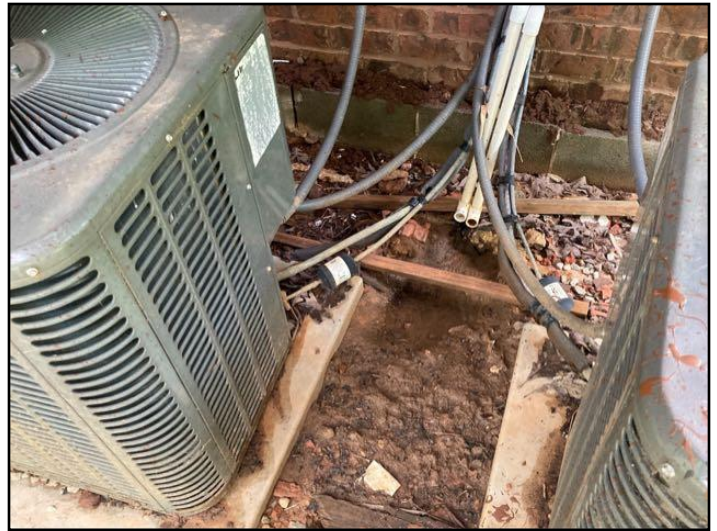
104. Condensate discharge location

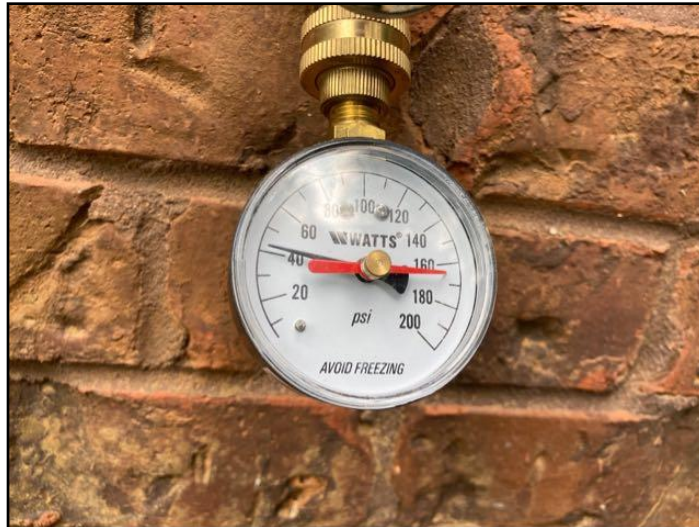
The water pressure was within the recommended 40-80 psi range. The pressure was 43 psi during testing.

110. Water pressure= 43 psi

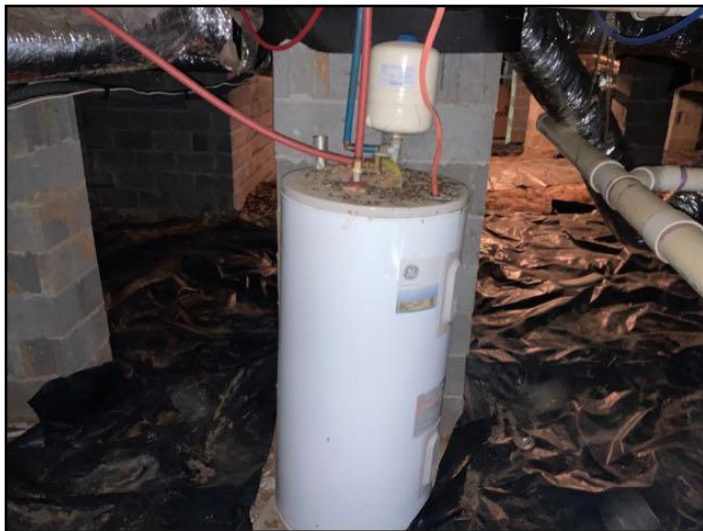
The water heater was functional during the inspection. The water heater includes an expansion tank as currently required. The water heater was manufactured in 2011. A drain pan is not installed. Monitor the crawlspace ground for signs of moisture/leaks.

112. View of water heater

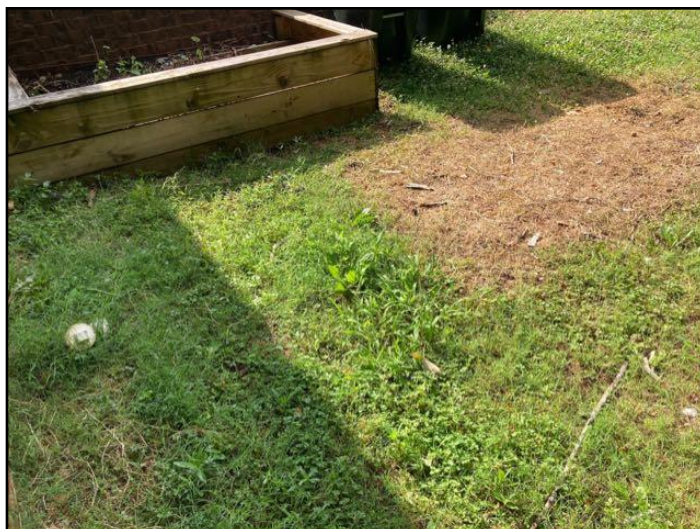
The building is presumed to be on a private septic system. I have no information regarding the planning, installation, size, performance, or other construction details of the septic system. A pump alarm is attached to the exterior left side wall. A clean-out cap and likely tank or pump access point are also visible in the left side yard (the brown grass area may indicate the tank lid location). Verify the septic/waste disposal details with the home seller. Consider having any septic system serviced.

115. Septic system/ pump location

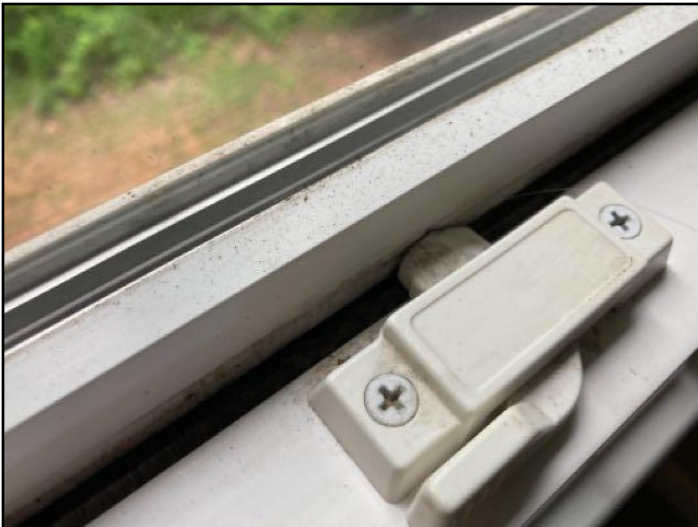
One living room window has a detached sash cord/attachment. Repair the window. Some windows have misaligned locks or were difficult to lock (one master bedroom, one sunroom, and one upper left bedroom). Adjust/improve the window locks where needed.

116. Lock not aligned

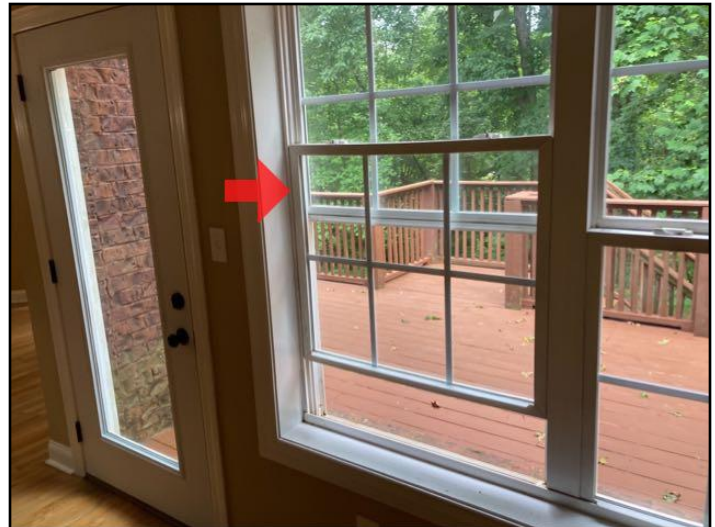
117. Detached sash

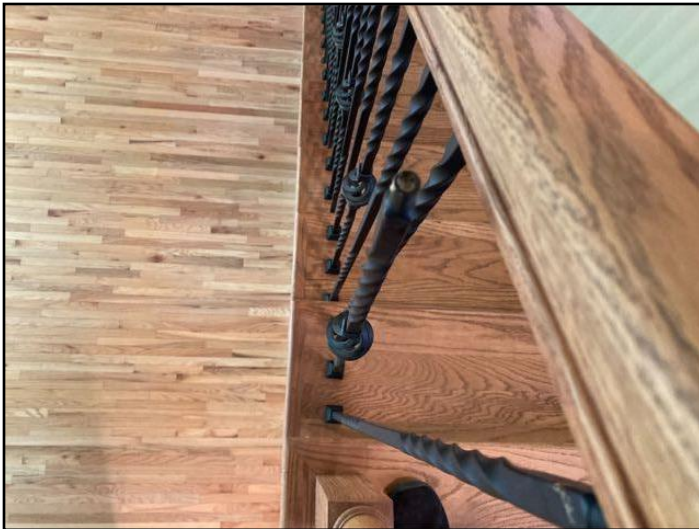
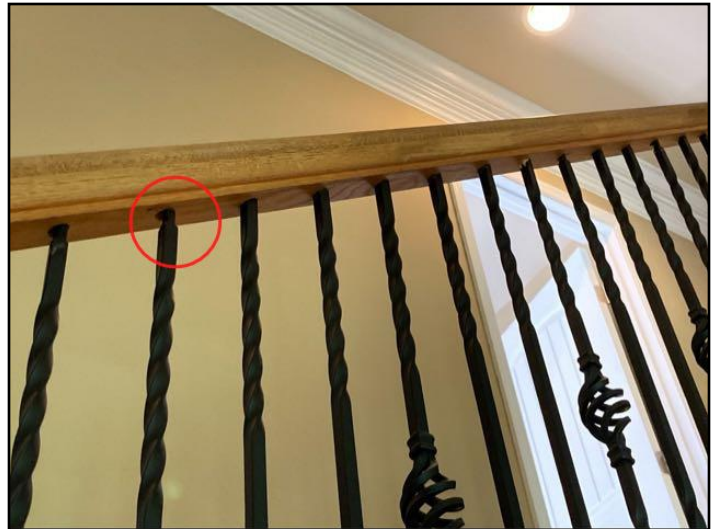
The interior stair handrail is loose. Several of the balusters pop out of place. Repair the handrail.

124. Rail baluster out-of-place

125. Rail baluster out-of-place

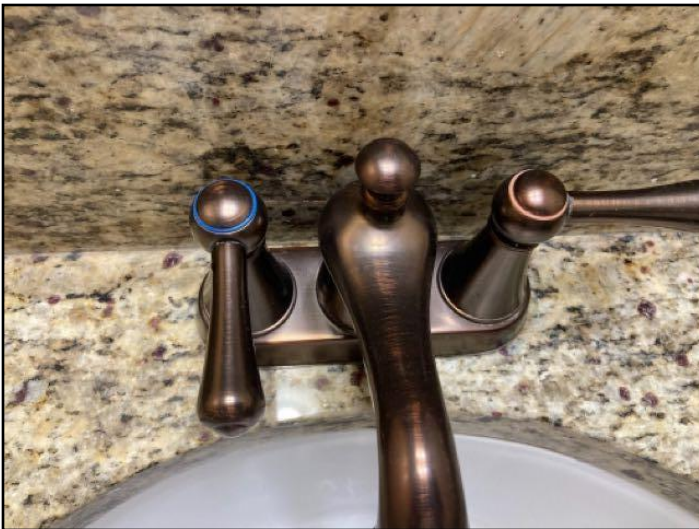
The upper hall bathroom hot & cold controls are reversed (the red-colored faucet provides cold water & the blue colored handle provides hot water). Improve/reverse if desired.

129. Red/blue coloring reversed

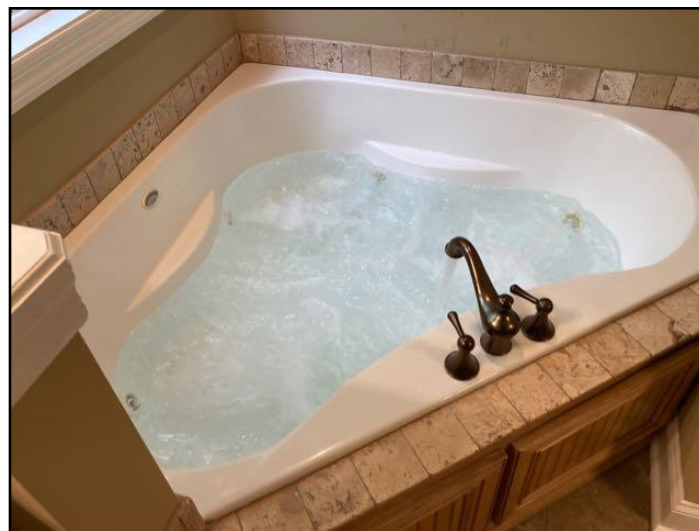
The access panels for the jetted tub motor & plumbing do not stay in place consistently. One of the panels is missing one of the latching pieces. Improve the access panels.

133. Jetted tub is functional
